# Test Report

Report No.: 838420T

- Assignor:** Nordic Build A/S  
Bjernermarksvej 54  
DK-5700 Svendborg
- Subject:** **Test specimens according to NB-1, for the determination of shear strength of glue lines – see appendix 1.**

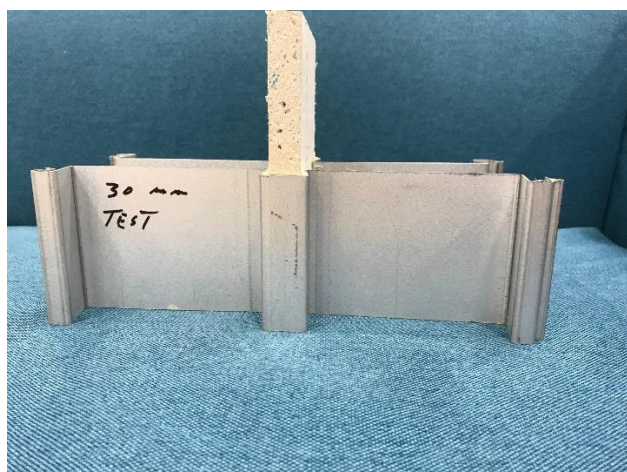
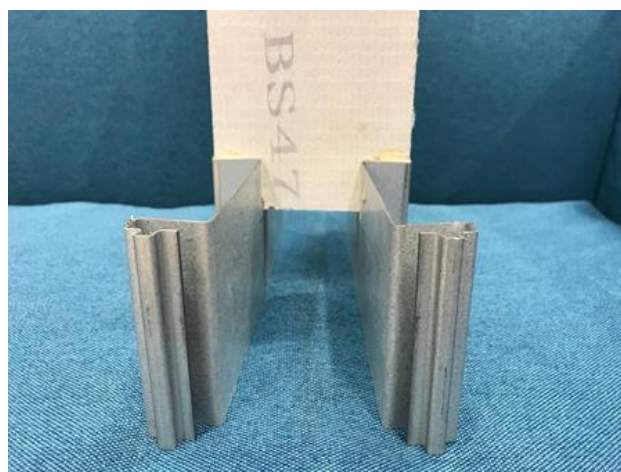
Test specimens – glue line length 20, 30 or 40 mm

Material	Description
Steel plate Swallow tail profile	0,9 mm DX51 D + AZ 150 AS  DX51 D = Standard steel, with tension strength 500 MPa AZ 150 AS = Surface treatment, AluZink minimum 150 g/m <sup>2</sup> , Normal appearance (A), Anti Fingerprint surface (S)
Panel	15 mm MAGPLY Magnesium Oxide Board with glass fibre mesh webbing. One side smooth. White
Glue	Base: Kestopur PL 5 - 10 <a href="https://pim.kiilto.com/kiilto-pim-api/api/pdf/download/5b11bbaee4b08a98c0299467">https://pim.kiilto.com/kiilto-pim-api/api/pdf/download/5b11bbaee4b08a98c0299467</a>  Hardener: Profect 91102 <a href="http://pki.dk/handler/download/PT91102_DK_SDS.pdf">http://pki.dk/handler/download/PT91102_DK_SDS.pdf</a>
	All descriptions are given by the assignor

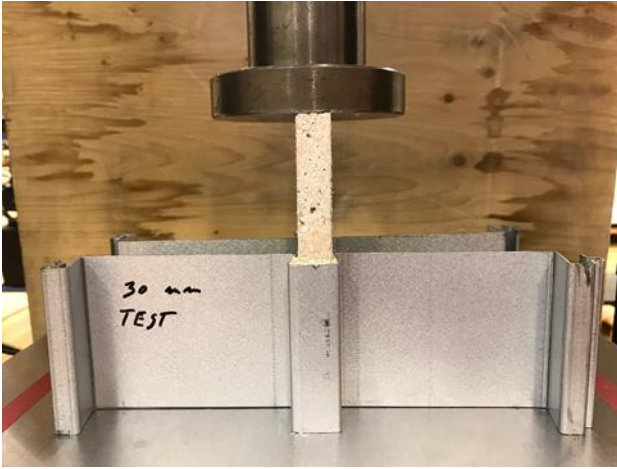
Test specimen in test machine

- Due to the lack of parallelity in the test specimens, a pivot bearing had to be built into the test set-up – see photo in Appendix 1.
- Dimensions of shear lines were measured for all specimens.

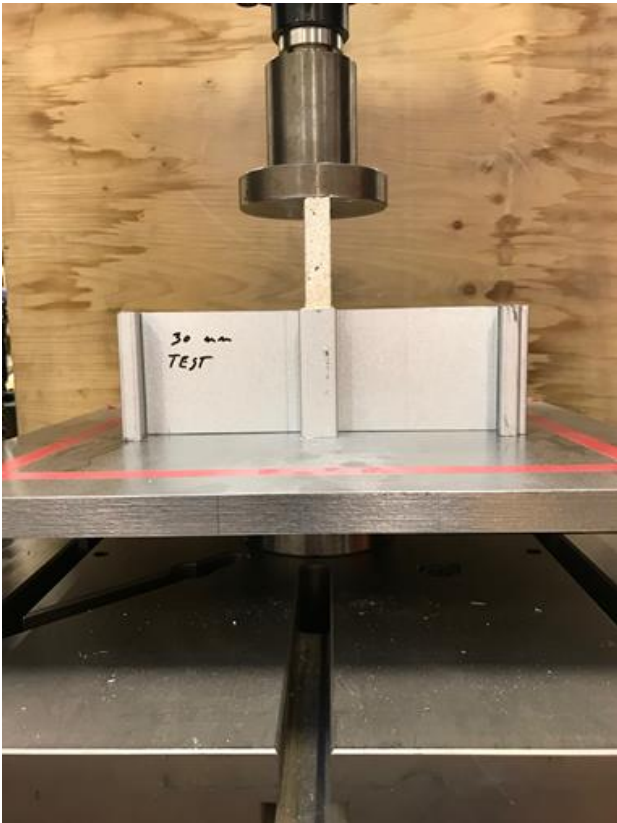
Test specimen in test machine

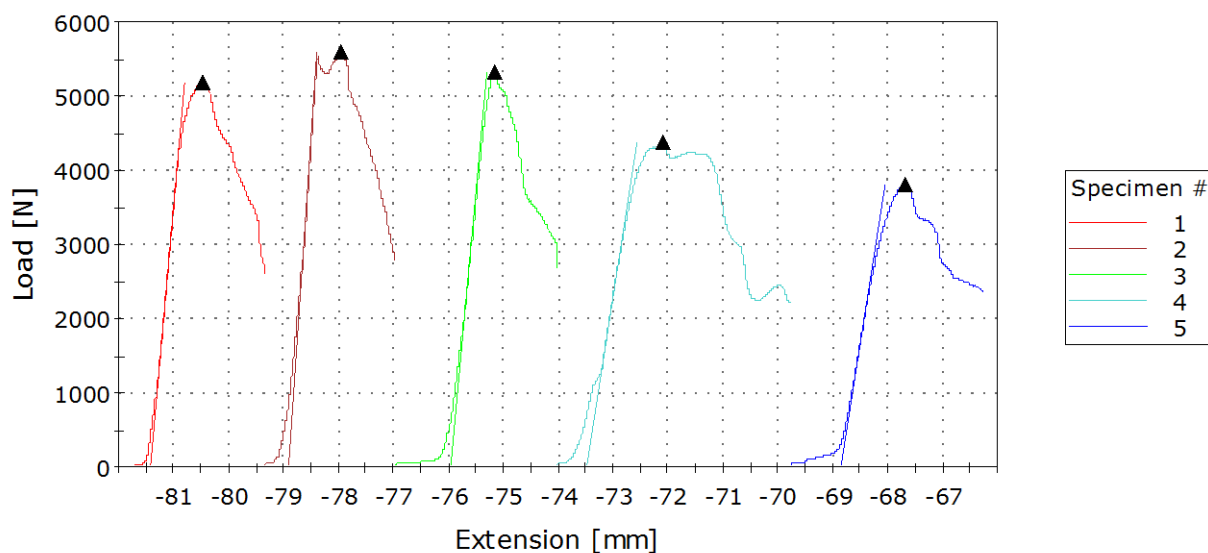
### Specimen 1 to 5

Specimen label	Shear length side 1 [mm]	Shear length side 2 [mm]	Maximum Load [N]	Extension at Maximum Load [mm]	Shear strength [N/mm]	Maximum Slope (Automatic Young's) [N/mm]	Time at Maximum Load [s]
	1	20-1	21,7	5185	-80,464	124,34	8186	38
	2	20-2	19,3	5591	1,379	142,98	10551	42
	3	20-3	19,4	5324	1,797	135,48	8047	54
	4	20-4	22,0	4372	1,940	99,60	4672	58
	5	20-5	22,3	3812	2,090	88,24	4618	63
Mean		20,9	20,5	4857	-14,652	<b>118,13</b>	<b>7215</b>	51
Standard deviation		1,5	0,9	740	36,791	23,42	2548	11
Coefficient of variation		7,0	4,4	15	-251,104	19,82	35	21

<b>Sample dimension</b>	<b>Shear strength [N/mm]</b>	<b>Stiffness [N/mm]</b>
20 mm	Mean value: 118,13	Mean value: 7215
30 mm	Mean value: 141,38	Mean value: 11204
40 mm	Mean value: 115,17	Mean value: 12647

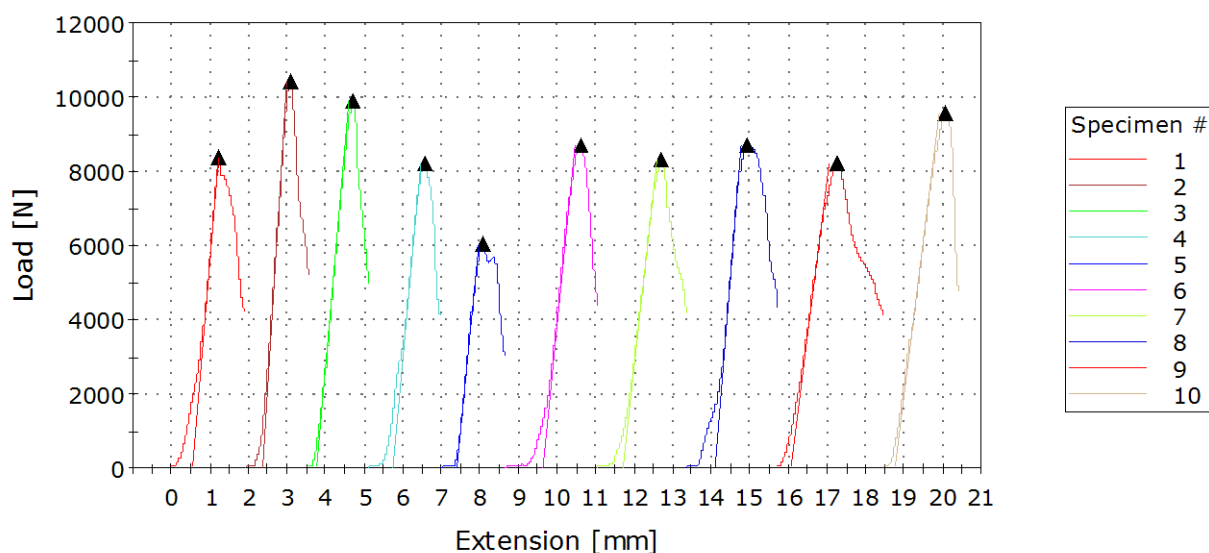
### Specimen 1 to 10

Specimen label	Shear length side 1 [mm]	Shear length side 2 [mm]	Maximum Load [N]	Extension at Maximum Load [mm]	Shear strength [N/mm]	Maximum Slope (Automatic Young's) [N/mm]	Time at Maximum Load [s]
	1	30-1	26,7	8380	1,249	155,48	12370	38
	2	30-2	30,8	10416	1,159	165,86	15667	35
	3	30-3	31,7	9904	1,160	157,20	12130	35
	4	30-4	30,8	8227	1,428	133,76	10984	43
	5	30-5	32,0	6051	1,085	92,81	11296	33
	6	30-6	31,4	8719	1,979	136,65	10467	60
	7	30-7	30,7	8304	1,654	135,24	9682	50
	8	30-8	28,5	8683	1,578	152,86	13177	48
	9	30-9	30,9	8234	1,562	131,53	8188	47
	10	30-10	31,5	9557	1,587	152,42	8080	48
	Mean		30,5	8647	1,444	<b>141,38</b>	<b>11204</b>	43
	Standard deviation		1,6	1193	0,281	20,75	2305	8
	Coefficient of variation		5,4	14	19,472	14,68	21	19

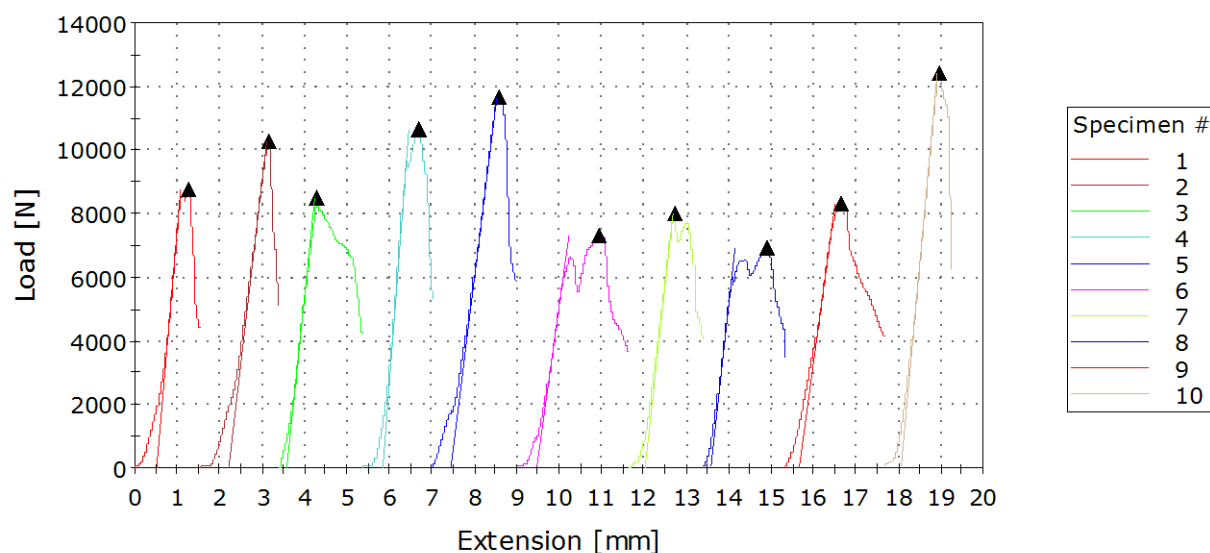
### Specimen 1 to 10

Specimen label	Shear length side 1 [mm]	Shear length side 2 [mm]	Maximum Load [N]	Extension at Maximum Load [mm]	Shear strength [N/mm]	Maximum Slope (Automatic Young's) [N/mm]	Time at Maximum Load [s]
1	40-1	39,9	39,0	8788	1,293	111,38	14978	39
2	40-2	41,8	40,4	10268	1,607	124,91	11817	48
3	40-3	39,1	39,4	8511	0,893	108,42	13413	27
4	40-4	39,7	41,1	10656	1,325	131,88	17687	40
5	40-5	38,7	39,4	11665	1,549	149,36	10727	47
6	40-6	39,4	42,7	7303	1,934	88,95	9976	58
7	40-7	39,4	41,4	8037	1,087	99,47	11676	33
8	40-8	39,2	42,2	6934	1,500	85,19	12189	45
9	40-9	40,0	42,6	8330	1,347	100,85	9972	40
10	40-10	41,7	40,5	12434	1,319	151,26	14031	40
Mean		39,9	40,9	9293	1,385	<b>115,17</b>	<b>12647</b>	42
Standard deviation		1,1	1,4	1862	0,287	23,44	2430	9
Coefficient of variation		2,6	3,3	20	20,691	20,35	19	21

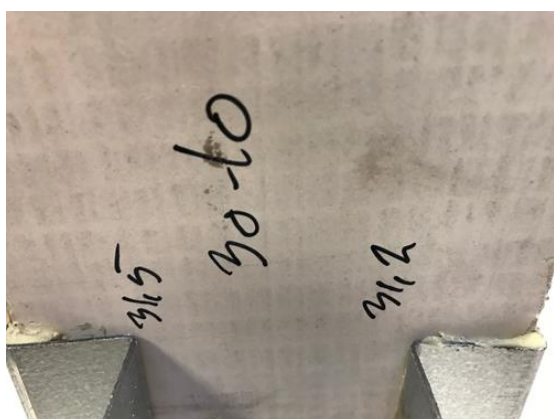
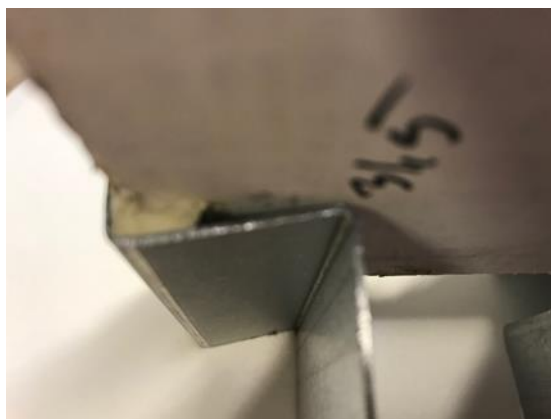
NG: Glue is missing in joint.

Lack of glue in specimen no. 30-10.

Failure modes			
Speciemn #	20 mm	30 mm	40 mm
1	2 x S	1 x S+ P	1 x S+ P
2	2 x S	1 x S	1 x S+ P
3	2 x S	1 x S	1 x S
4	1 x S	1 x S	1 x S
5	1 x S	1 x S	1 x S+ P
6	-	1 x S	1 x S
7	-	1 x S	1 x S + P
8	-	1 x S	1 x S + NG
9	-	1 x S + P	1 x S + P
10	-	1 x S +P + NG See photo below.	1 x S + P
