TEST REPORT NON-LOADBEARING WALL

Name of sponsor:	Nordic Build A/S		
Product name:	Non-loadbearing facade element		
File no.:	PGA11339A	Revision no.:	0
Test date:	10-12-2018	Date:	29-01-2019
Pages:	10	Encl.:	41
Ref:	RBI / ADR

Examination of the fire-resistance of a Non-loadbearing facade element.

EN 1364-1:2015 Fire resistance for non-loadbearing elements Part 1: Walls

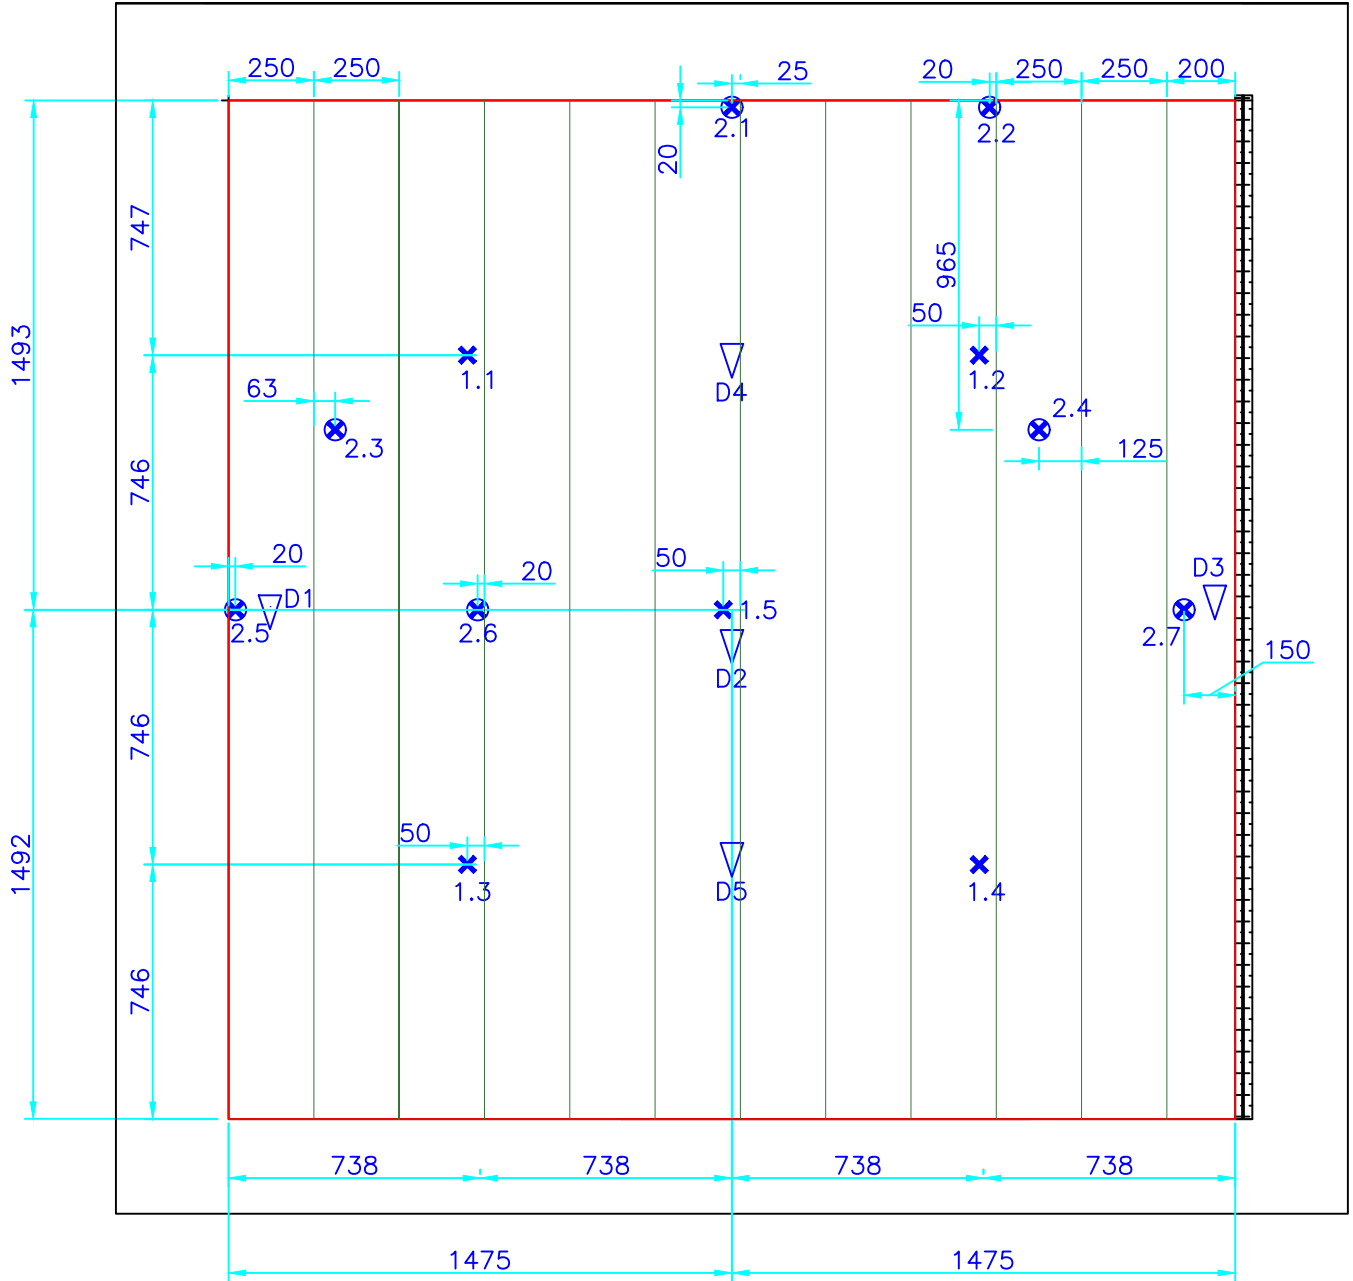
- ✘ Thermocouple placed on the unexposed surface (average)
- ⊗ Thermocouple placed on the unexposed surface (maximum)
- ▽ Deflection measuring point

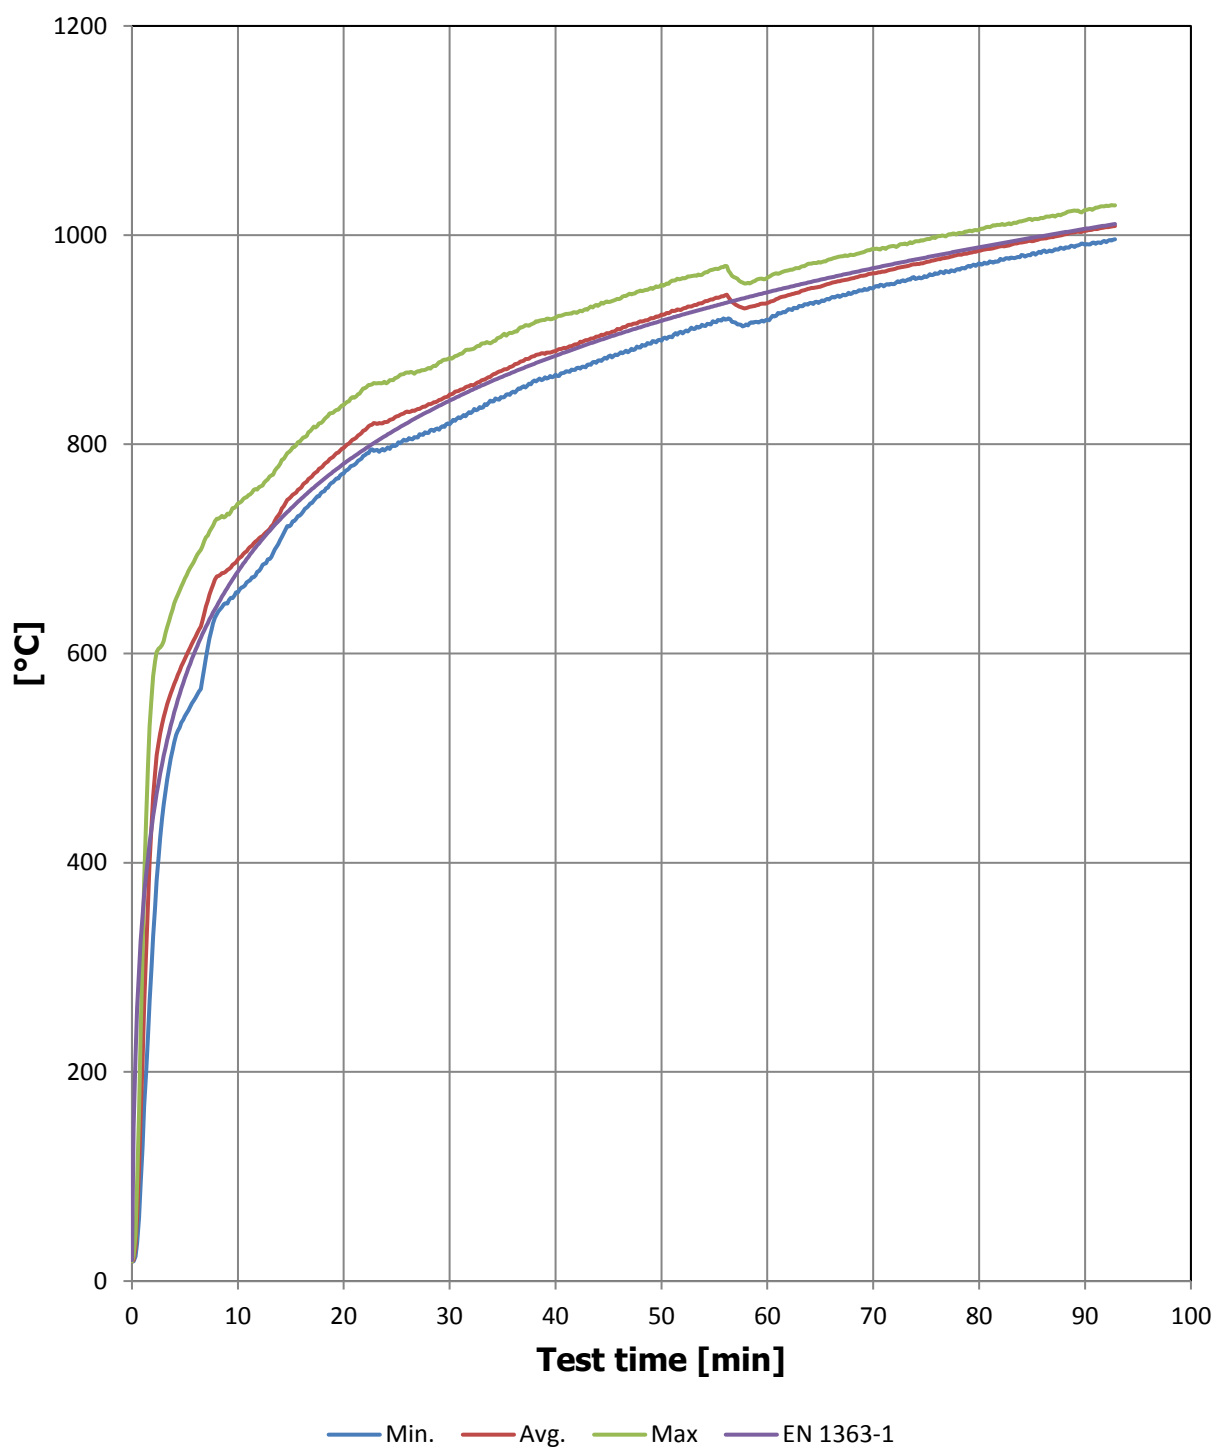
Furnace temperature

Time Minutes	Measured			Norm EN 1363-1	Area under curve		Dev. [%]	Limit [%]
	Minimum	Average	Maximum		Measured	EN 1363-1		
0	19	19	19	20	0	0	0,0	
3	456	539	612	502	944	1115	-15,3	
6	558	616	691	603	2690	2790	-3,6	15
9	648	680	734	663	4655	4695	-0,9	15
12	679	710	759	705	6739	6750	-0,2	14
15	723	750	794	739	8923	8918	0,1	13
18	755	779	822	766	11217	11176	0,4	11
21	780	805	845	789	13595	13508	0,6	10
24	796	821	858	809	16042	15904	0,9	8
27	807	834	870	826	18527	18357	0,9	7
30	819	848	883	842	21047	20859	0,9	5
33	835	861	896	856	23609	23406	0,9	5
36	850	875	907	869	26214	25994	0,8	5
39	864	887	919	881	28860	28619	0,8	4
42	873	895	926	892	31533	31279	0,8	4
45	884	906	936	902	34237	33971	0,8	4
48	893	918	947	912	36973	36692	0,8	4
51	902	928	957	921	39739	39442	0,8	3
54	913	936	964	930	42533	42218	0,7	3
57	916	934	959	938	45350	45019	0,7	3
60	919	935	959	945	48147	47844	0,6	3
63	933	945	968	953	50969	50691	0,5	3
66	940	954	977	960	53819	53559	0,5	3

69	947	961	984	966	56692	56448	0,4	3
72	953	968	990	973	59585	59356	0,4	3
75	960	974	996	979	62498	62283	0,3	3
78	967	981	1002	985	65431	65228	0,3	3
81	975	987	1008	990	68383	68190	0,3	3
84	981	993	1013	996	71353	71169	0,3	3
87	985	998	1019	1001	74340	74164	0,2	3
90	991	1004	1024	1006	77344	77175	0,2	3
92	993	1008	1028	1009	79356	79190	0,2	3

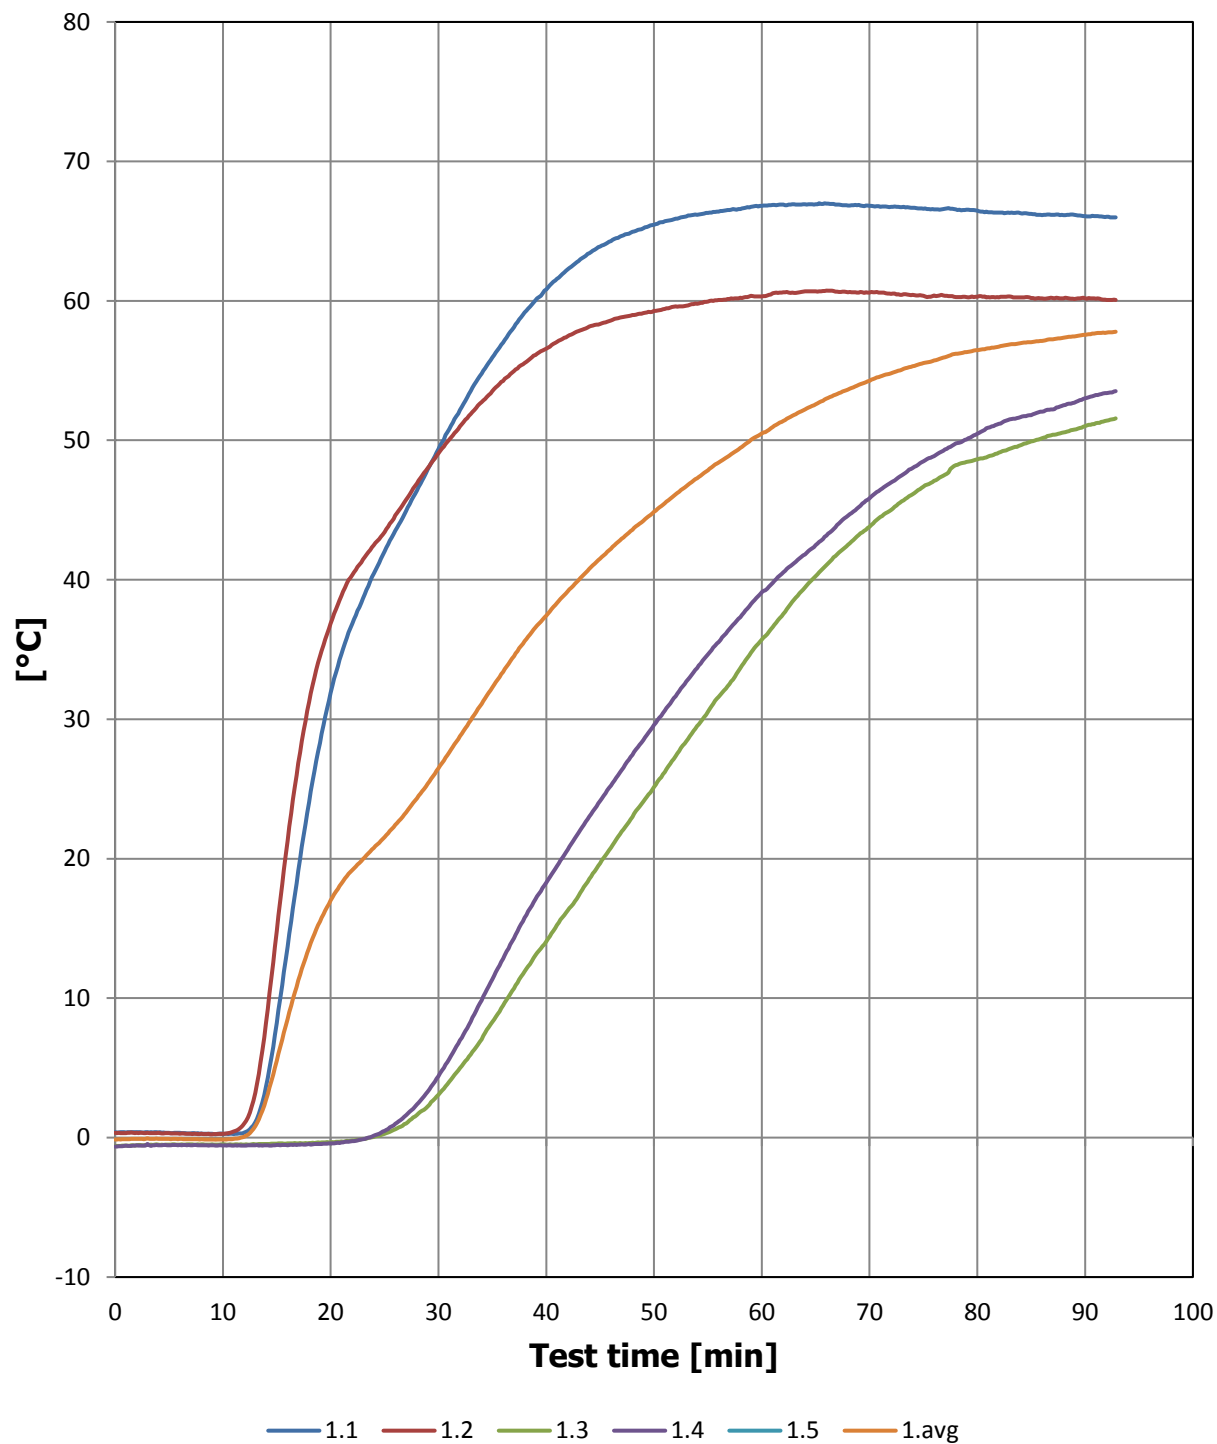
Measured with 5 thermocouples

Average temperature rise

Min. / °C	1.1	1.2	1.3	1.4	1.5	1.Avg	1.Max
0	0	0	-1	-1	0	0	0
3	0	0	0	0	0	0	0
6	0	0	0	-1	0	0	0
9	0	0	0	-1	0	0	0
12	0	1	-1	-1	0	0	1
15	8	15	0	-1	0	6	15
18	24	31	0	0	0	14	31
21	35	39	0	0	0	18	39
24	40	42	0	0	0	21	42
27	45	46	1	2	0	23	46
30	49	49	3	4	0	26	49
33	54	52	6	8	0	30	54
36	57	54	9	13	0	33	57
39	60	56	13	17	0	37	60
42	62	57	16	21	0	39	62
45	64	58	20	24	0	42	64
48	65	59	23	27	0	44	65
51	66	59	26	31	0	45	66
54	66	60	30	34	0	47	66
57	67	60	33	36	0	49	67
60	67	60	36	39	0	50	67
63	67	61	39	41	0	52	67
66	67	61	41	43	0	53	67
69	67	61	43	45	0	54	67
72	67	60	45	47	0	55	67
75	67	60	47	48	0	56	67
78	67	60	48	50	0	56	67
81	66	60	49	51	0	57	66
84	66	60	50	52	0	57	66
87	66	60	50	52	0	57	66
90	66	60	51	53	0	58	66
92	66	60	51	53	0	58	66

Failure [min]	-	-	-	-	-	-	-
Failure °C	180	180	180	180	180	140	180

- Failure of insulation did not occur during the test
- The average temperature rise on the unexposed surface of the test specimen did not exceed 140 °C during the test
- The maximum temperature rise on the unexposed surface of the test specimen did not exceed 180 °C during the test

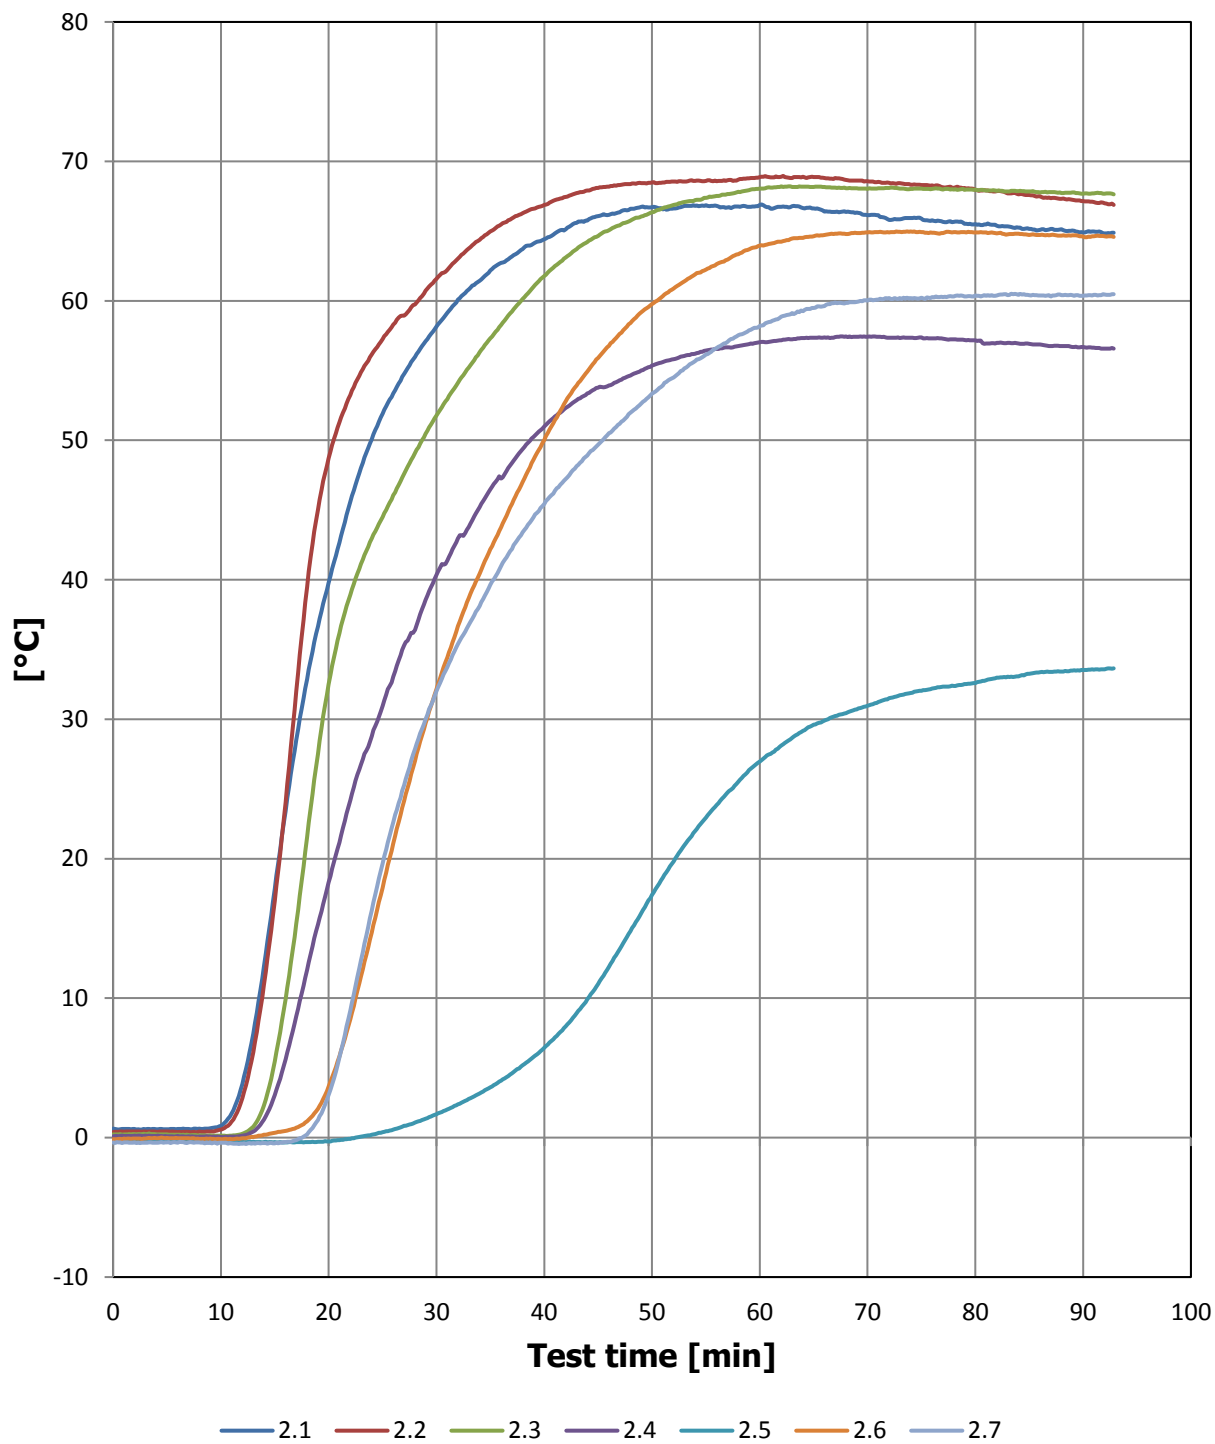
Maximum temperature rise on the unexposed side

Maximum temperature rise

Min. / °C	2.1	2.2	2.3	2.4	2.5	2.6	2.7	2.Max
0	1	0	0	0	0	0	0	1
3	1	0	0	0	0	0	0	1
6	1	0	0	0	0	0	0	1
9	1	0	0	0	0	0	0	1
12	4	3	0	0	0	0	0	4
15	18	17	5	3	0	0	0	18
18	33	39	22	12	0	1	0	39
21	43	51	36	21	0	6	6	51
24	50	56	43	29	0	15	16	56
27	55	59	48	35	1	24	25	59
30	58	62	52	40	2	32	32	62
33	61	64	55	44	3	39	37	64
36	63	65	58	47	4	44	41	65
39	64	67	61	50	6	49	44	67
42	65	67	63	52	8	53	47	67
45	66	68	65	54	11	56	50	68
48	67	68	66	55	15	58	52	68
51	67	68	67	56	19	60	54	68
54	67	69	67	56	22	62	56	69
57	67	69	68	57	25	63	57	69
60	67	69	68	57	27	64	58	69
63	67	69	68	57	29	64	59	69
66	66	69	68	57	30	65	60	69
69	66	69	68	57	31	65	60	69
72	66	68	68	57	32	65	60	68
75	66	68	68	57	32	65	60	68
78	66	68	68	57	32	65	60	68
81	65	68	68	57	33	65	60	68
84	65	68	68	57	33	65	60	68
87	65	67	68	57	33	65	60	68
90	65	67	68	57	34	65	60	68
92	65	67	68	57	34	65	60	68

Failure [min]	-	-	-	-	-	-	-	-
Failure °C	180	180	180	180	180	180	180	180

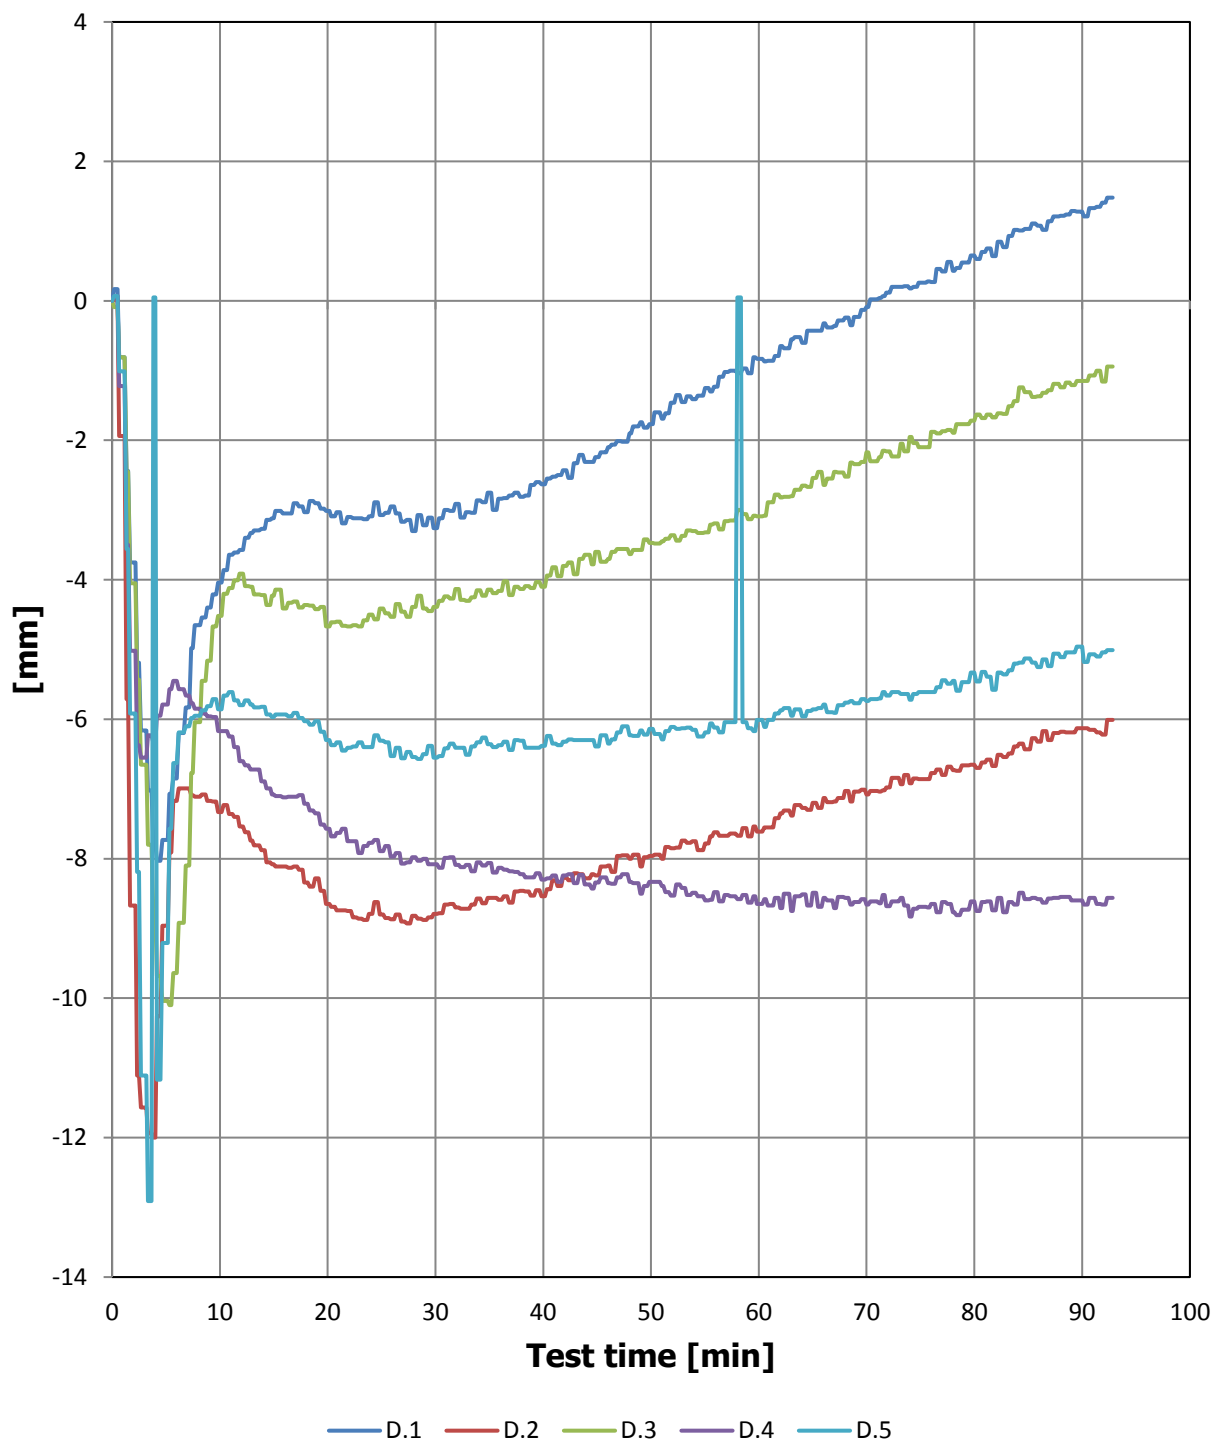
Negative values indicates movement towards the furnace

Deformation

Min. / mm	D.1	D.2	D.3	D.4	D.5
0	0,0	0,0	0,0	0,0	0,0
3	-6,2	-11,6	-6,7	-6,6	-11,1
6	-6,9	-7,2	-9,6	-5,5	-6,6
9	-4,4	-7,2	-5,2	-6,0	-5,8
12	-3,6	-7,5	-3,9	-6,6	-5,8
15	-3,1	-8,1	-4,2	-7,1	-6,0
18	-3,0	-8,3	-4,4	-7,2	-6,0
21	-3,0	-8,7	-4,6	-7,6	-6,3
24	-3,1	-8,8	-4,5	-7,8	-6,4
27	-3,2	-8,9	-4,5	-8,1	-6,6
30	-3,3	-8,8	-4,4	-8,1	-6,6
33	-3,0	-8,7	-4,3	-8,1	-6,5
36	-2,8	-8,6	-4,2	-8,1	-6,4
39	-2,6	-8,5	-4,1	-8,3	-6,4
42	-2,4	-8,3	-3,8	-8,2	-6,3
45	-2,2	-8,2	-3,6	-8,3	-6,4
48	-1,9	-8,0	-3,6	-8,3	-6,2
51	-1,7	-8,0	-3,5	-8,4	-6,3
54	-1,4	-7,8	-3,3	-8,5	-6,2
57	-1,0	-7,7	-3,2	-8,5	-6,0
60	-0,8	-7,6	-3,1	-8,7	-6,0
63	-0,6	-7,4	-2,8	-8,8	-6,0
66	-0,3	-7,1	-2,6	-8,6	-5,8
69	-0,2	-7,0	-2,3	-8,6	-5,8
72	0,1	-7,0	-2,2	-8,7	-5,7
75	0,3	-6,9	-2,1	-8,7	-5,6
78	0,4	-6,7	-1,9	-8,8	-5,5
81	0,7	-6,6	-1,7	-8,6	-5,3
84	1,0	-6,4	-1,4	-8,7	-5,2
87	1,1	-6,3	-1,3	-8,6	-5,2
90	1,3	-6,1	-1,2	-8,6	-5,0
92	1,4	-6,2	-1,2	-8,7	-5,0

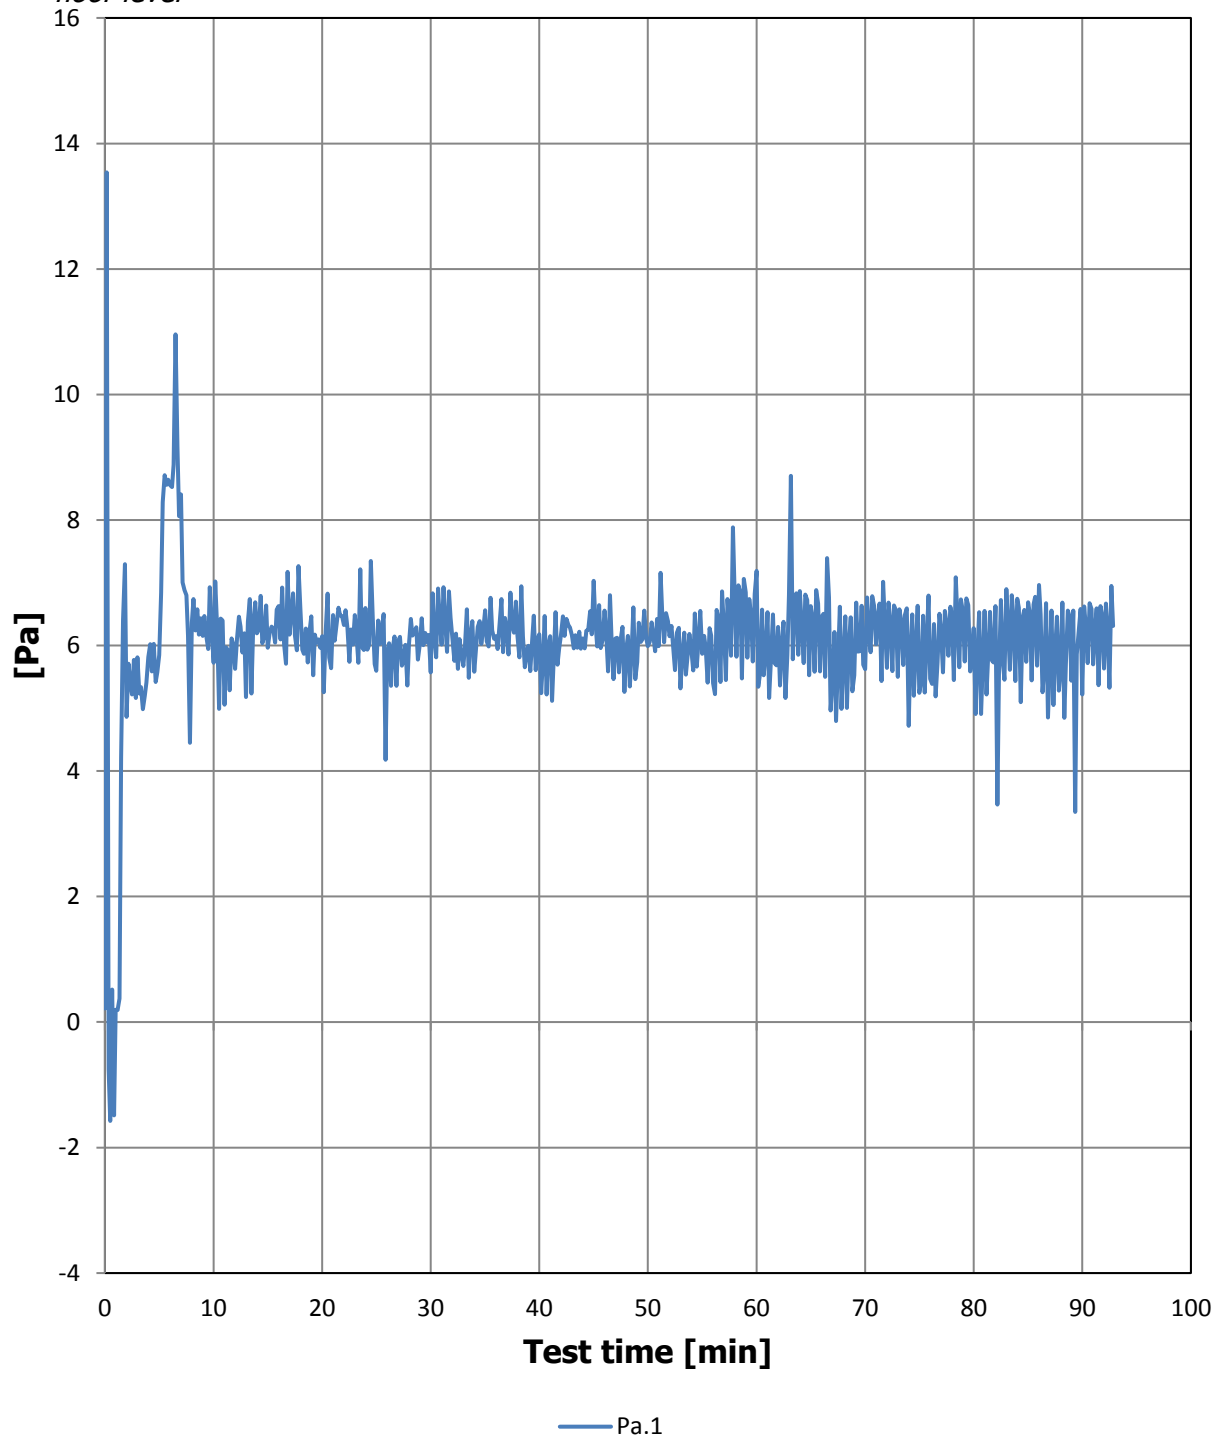
The differential pressure in the furnace during the test, measured 1,16 m above notional floor level

Vertical furnace pressure

Min. / Pa	Pa.1
0	0,2
3	5,8
6	8,6
9	6,2
12	5,6
15	6,0
18	6,6
21	6,5
24	6,6
27	6,1
30	5,6
33	5,7
36	6,1
39	6,0
42	6,2
45	7,0
48	5,9
51	6,0
54	5,9
57	6,3
60	7,2
63	6,8
66	6,5
69	5,5
72	5,6
75	5,2
78	6,5
81	6,6
84	6,7
87	5,6
90	5,2
92	5,6

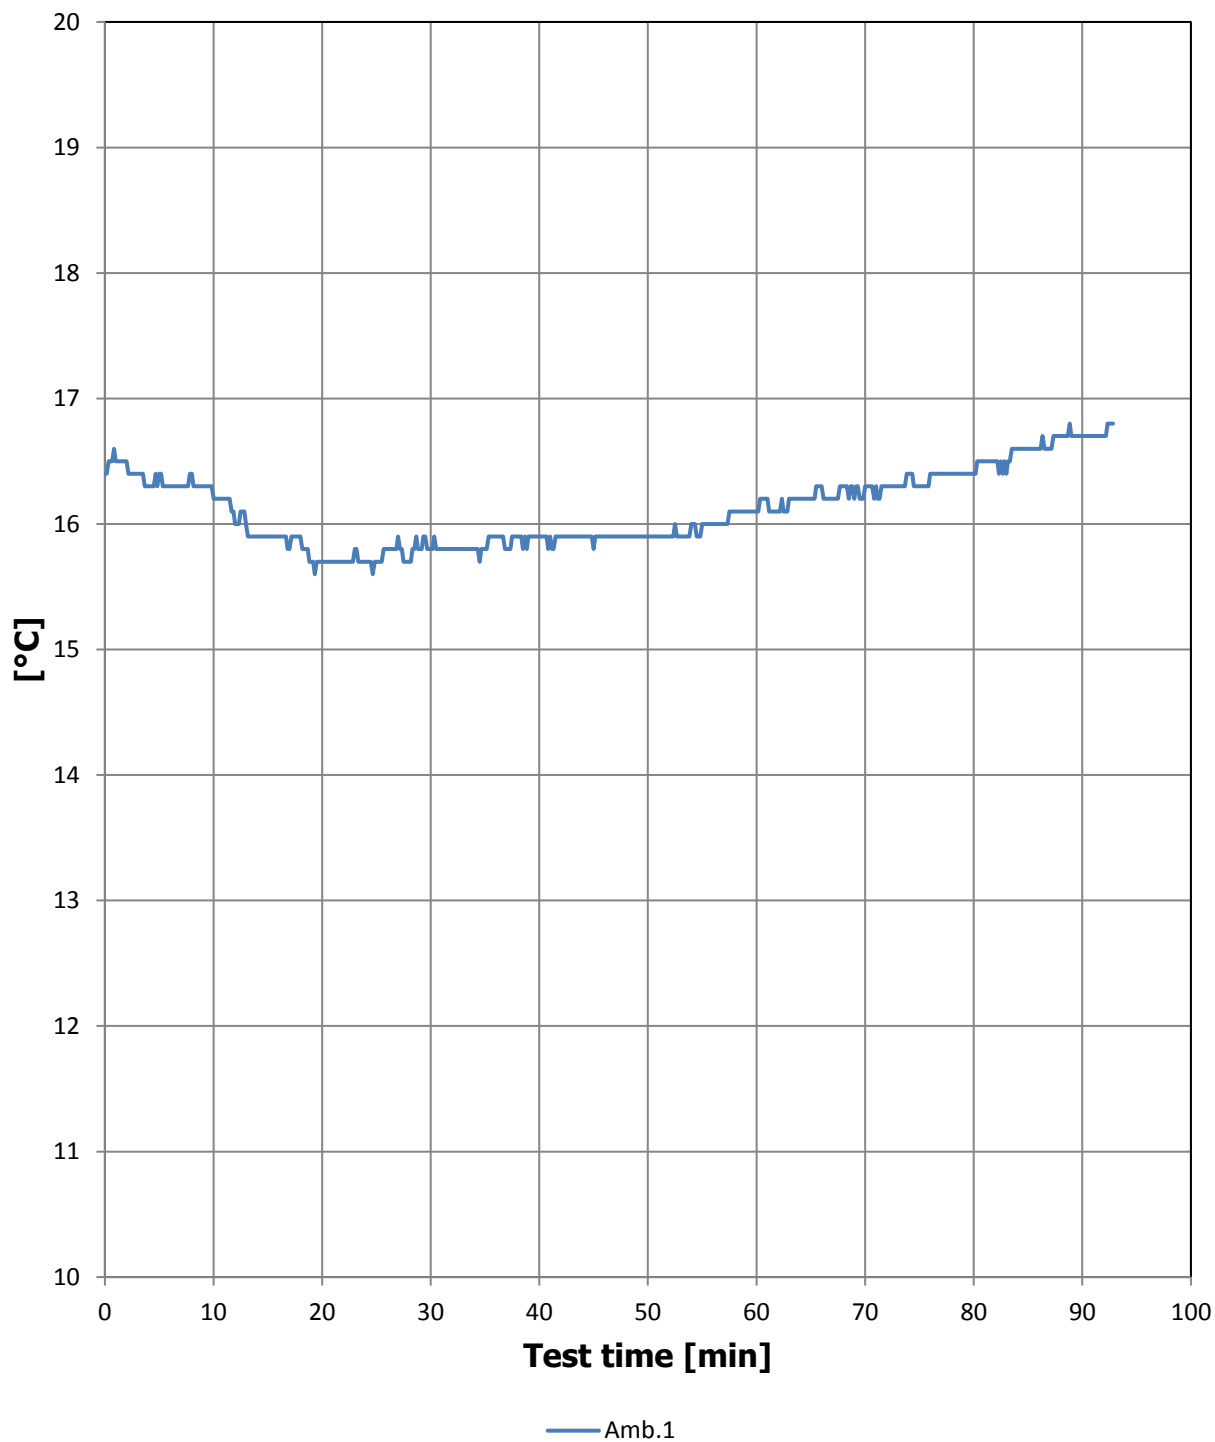
Ambient temperature

The ambient temperature in the laboratory during the test

Min. / °C	Amb.1
0	16,4
3	16,4
6	16,3
9	16,3
12	16,0
15	15,9
18	15,9
21	15,7
24	15,7
27	15,9
30	15,8
33	15,8
36	15,9
39	15,9
42	15,9
45	15,8
48	15,9
51	15,9
54	16,0
57	16,0
60	16,1
63	16,2
66	16,3
69	16,2
72	16,3
75	16,3
78	16,4
81	16,5
84	16,6
87	16,6
90	16,7
92	16,7

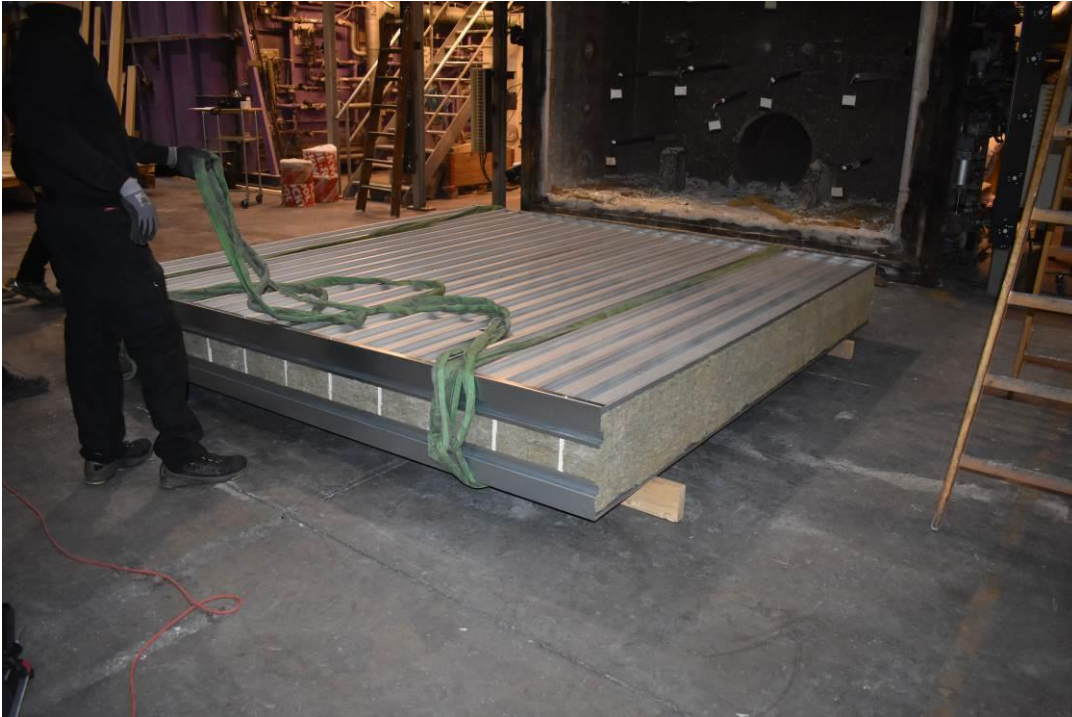
Photo No. 1 The test specimen before mounting

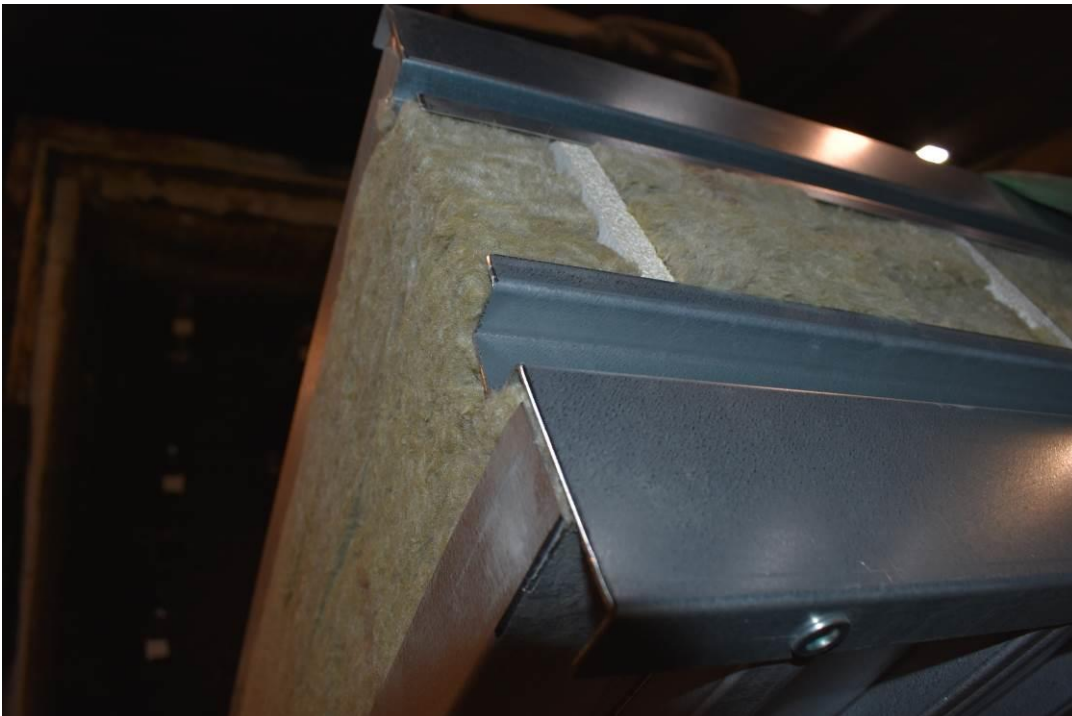
Photo No. 2 Upper edge of test specimen – edge profile of galvanized steel, seen at free edge

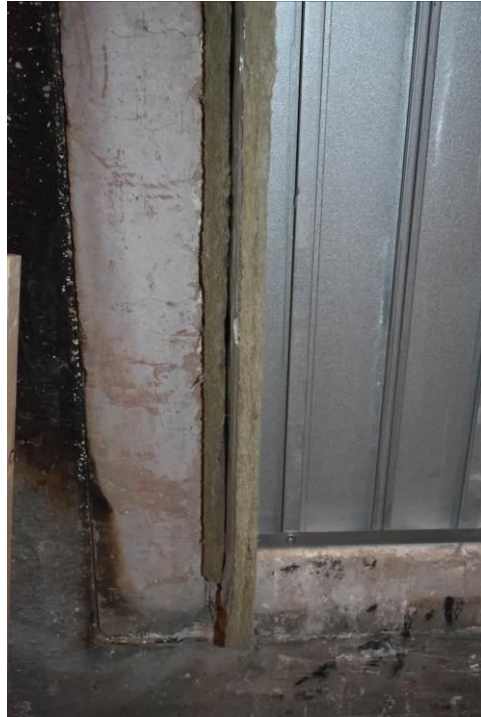
Photo No. 3 The test specimen seen from exposed side at free edge – packed with stone wool

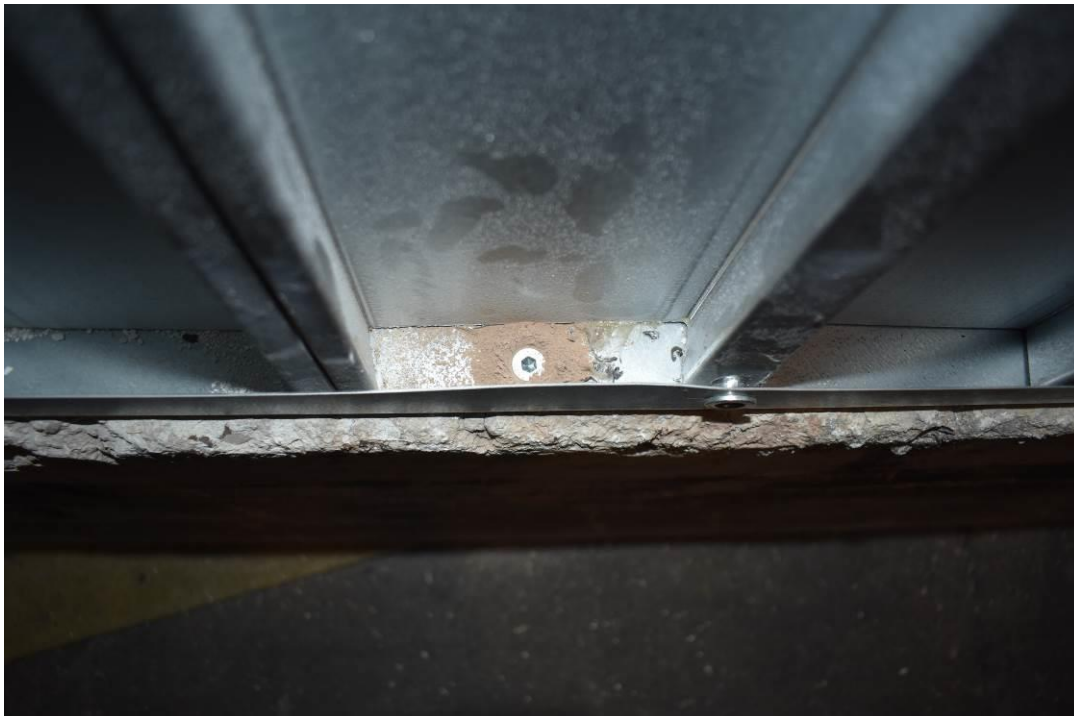
Photo No. 4 The test specimen seen from exposed side at lower edge – attached to the concrete frame with screws

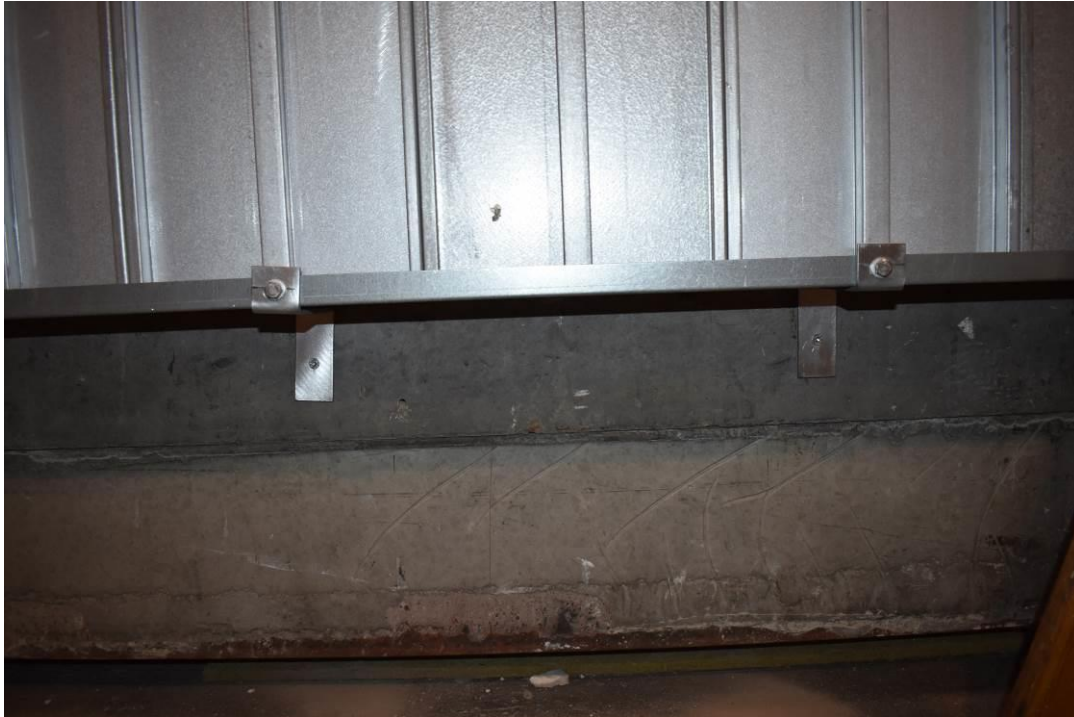
Photo No. 5 The test specimen seen from unexposed side at lower edge – attached to the concrete frame with Z-profiles

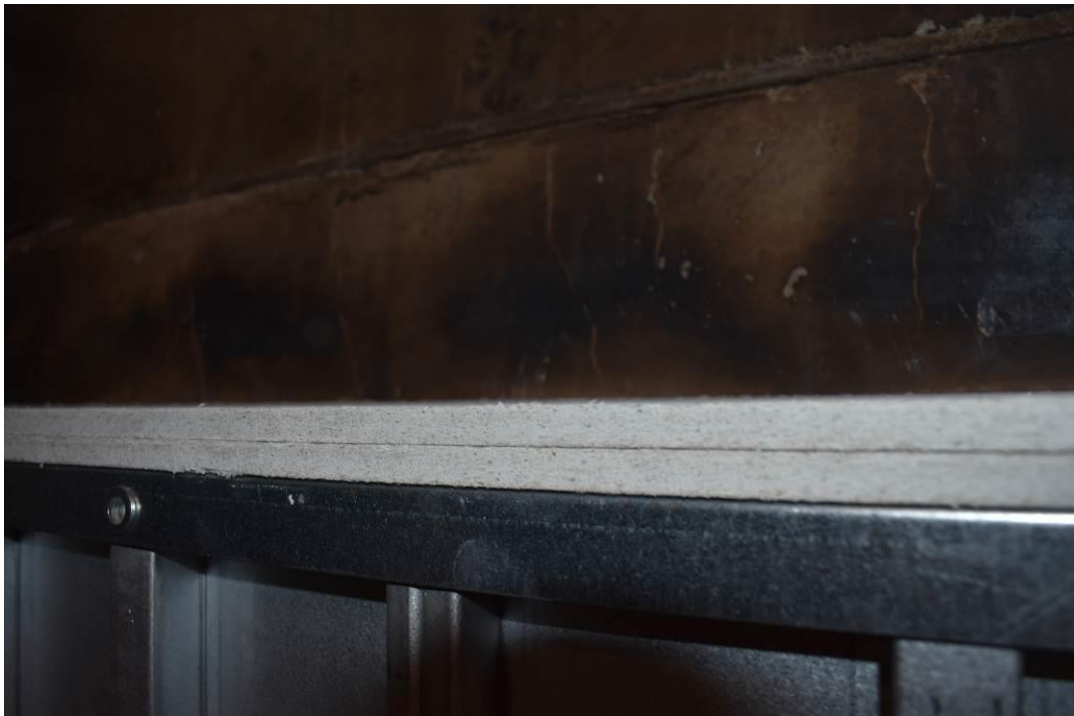
Photo No. 6 The test specimen seen from unexposed side at upper edge – packed with non-combustible boards

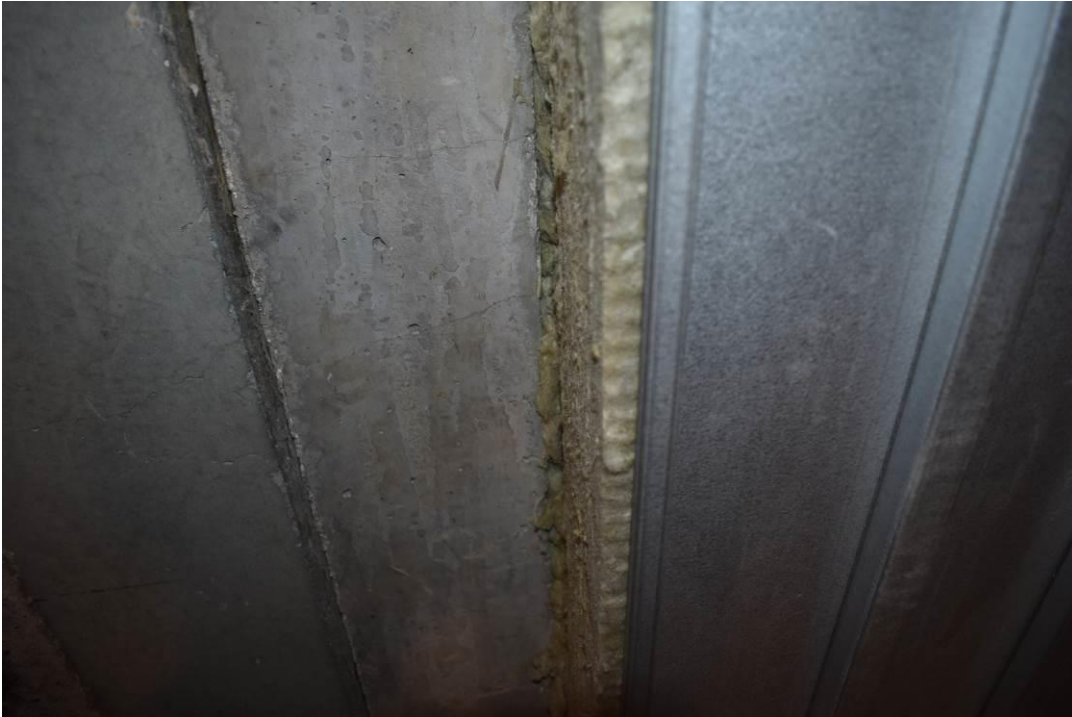
Photo No. 7 The test specimen seen from unexposed side at fixed edge

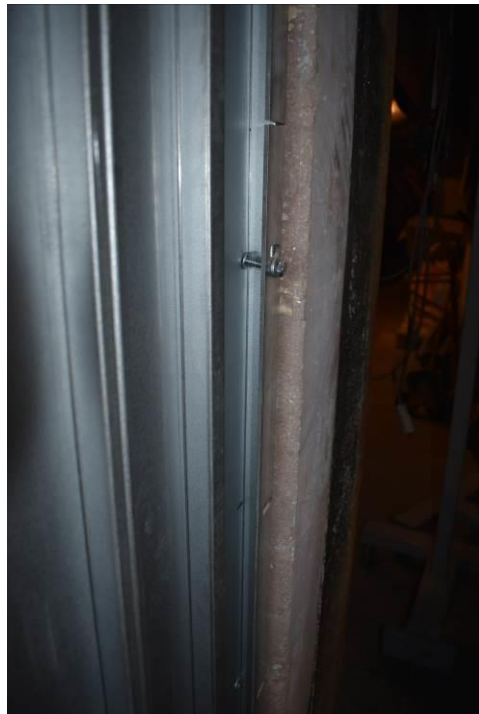
Photo No. 8 The test specimen seen from exposed side at fixed edge – attached to the concrete frame via steel profile

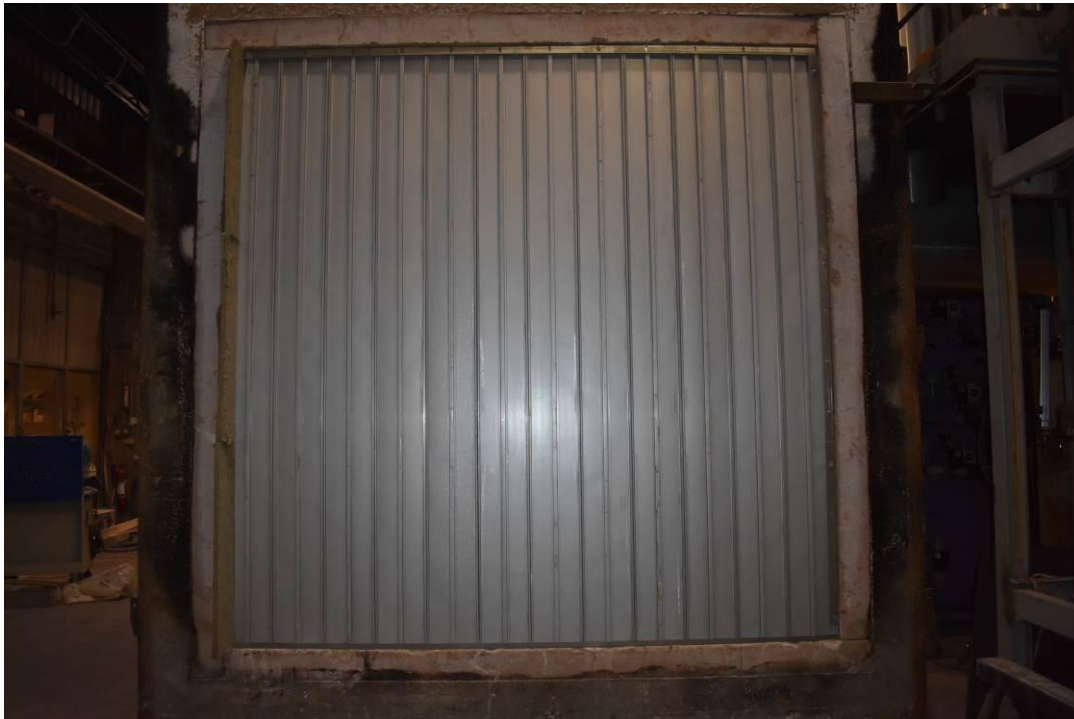
Photo No. 9 The test specimen seen from exposed side before testing

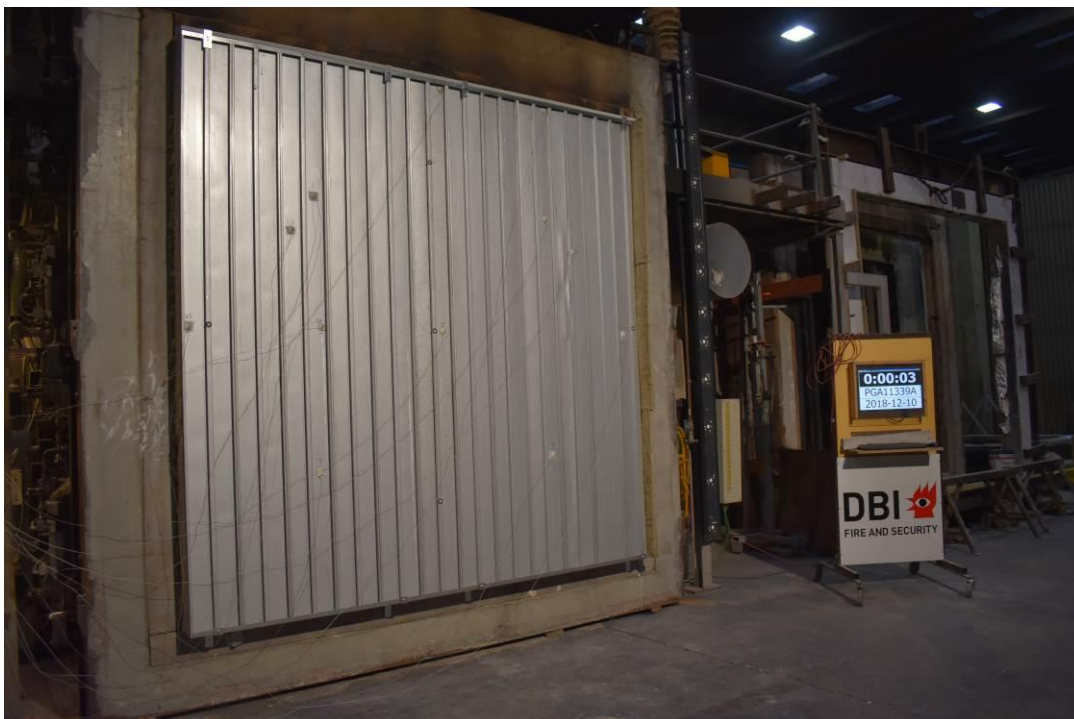
Photo No. 10 The test specimen seen from unexposed side at test start

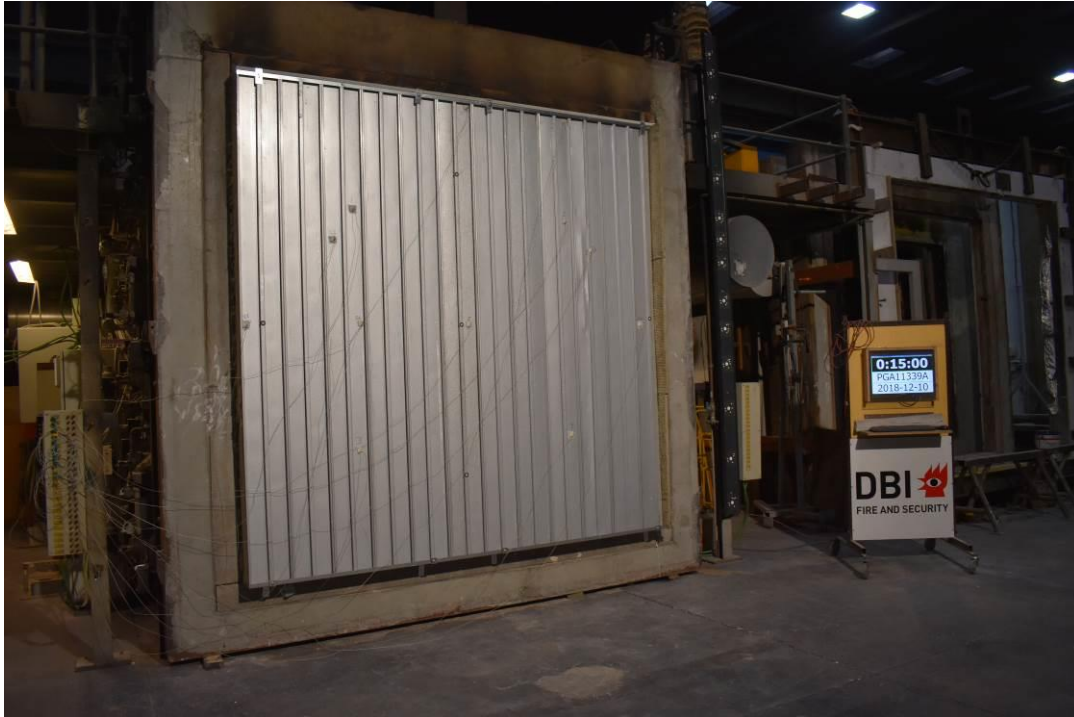
Photo No. 11 The test specimen seen from unexposed side after 15 minutes of testing

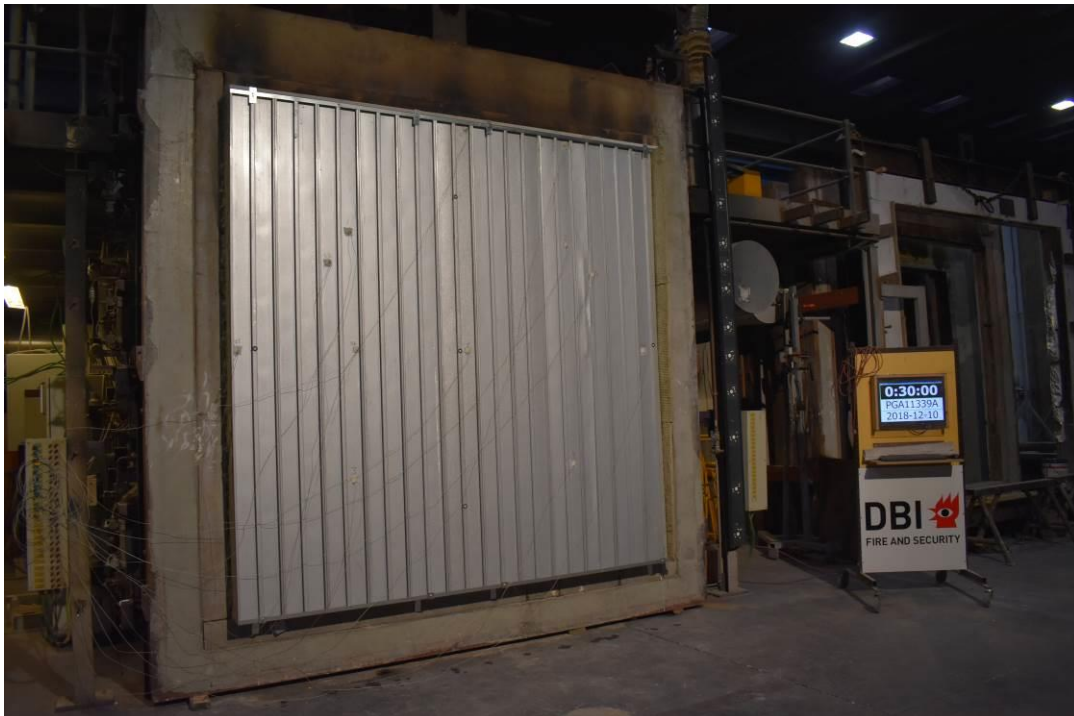
Photo No. 12 The test specimen seen from unexposed side after 30 minutes of testing
