TEST REPORT NON-LOADBEARING WALL

Name of sponsor:	Nordic Build A/S		
Product name:	Non-loadbearing facade element		
File no.:	PGA11339A	Revision no.:	0
Test date:	10-12-2018	Date:	29-01-2019
Pages:	10	Encl.:	41
Ref:	RBI / ADR

Examination of the fire-resistance of a Non-loadbearing facade element.

EN 1364-1:2015 Fire resistance for non-loadbearing elements Part 1: Walls

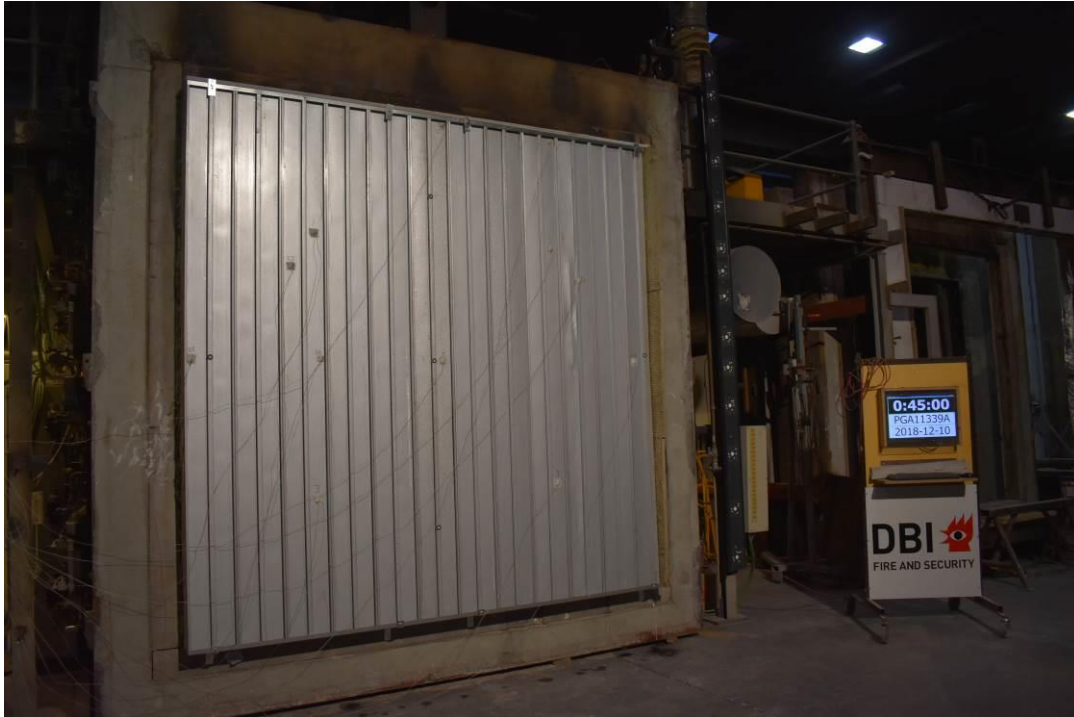
Photo No. 13 The test specimen seen from unexposed side after 45 minutes of testing

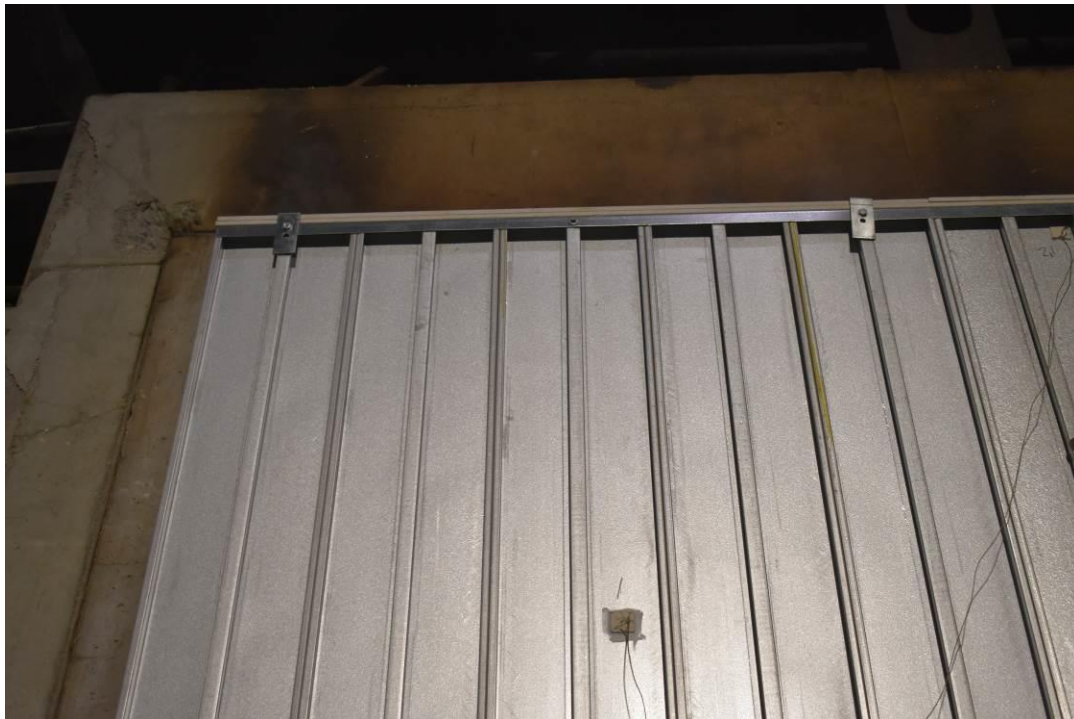
Photo No. 14 Discoloration of joint no. 4 seen from fixed edge

57	Discoloration along vertical joint no. 4 seen from fixed edge	U
59	No cotton pad test was performed as the occasion of failure of integrity was not relevant	U
60	Gap between non-combustible boards and steel profiles	E
65	Continuing water released from specimen	U
72	Nothing new to observe	U
89	No cotton pad test was performed as the occasion of failure of integrity was not relevant	U
92	Test stopped

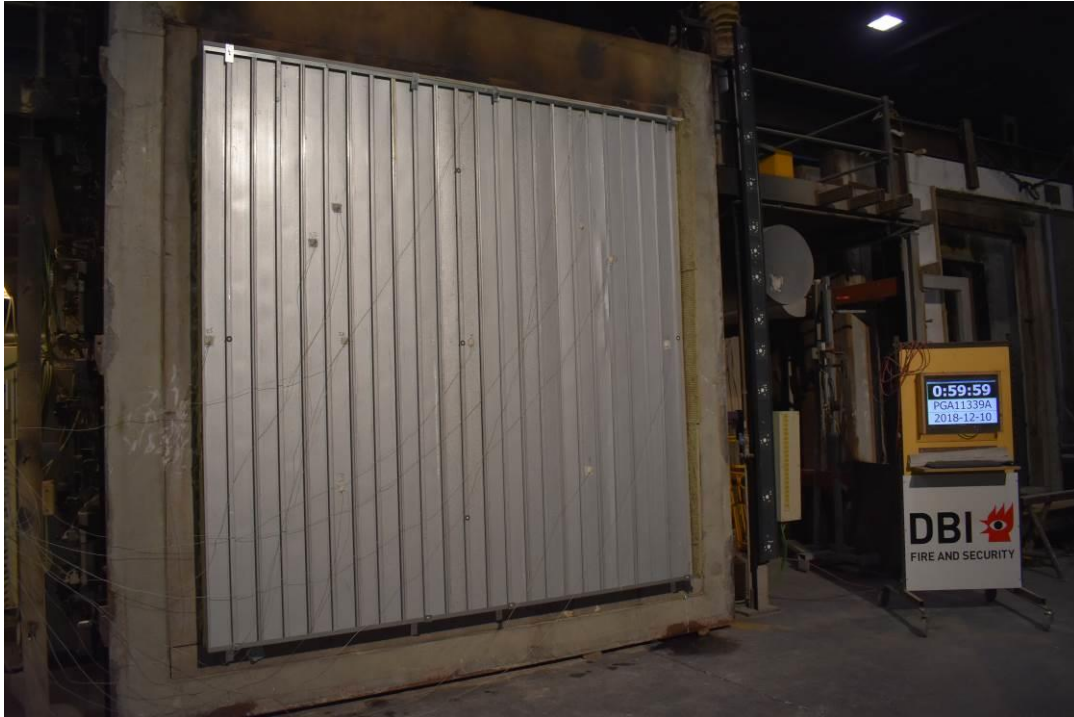
Photo No. 15 The test specimen seen from unexposed side after 60 minutes of testing

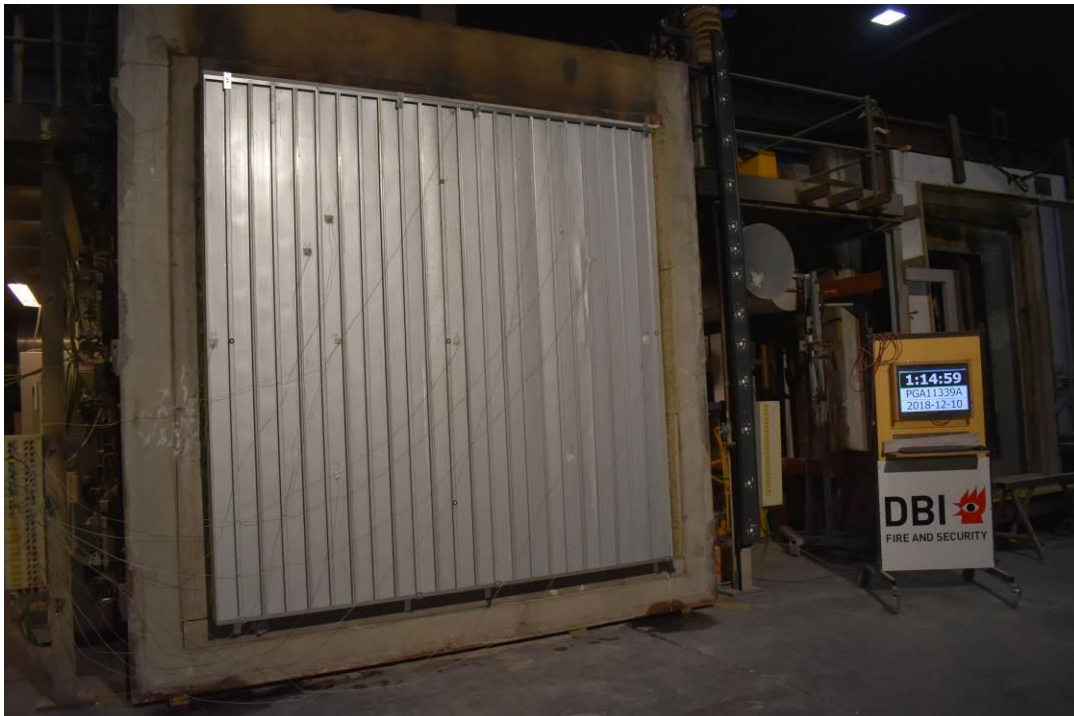
Photo No. 16 The test specimen seen from unexposed side after 75 minutes of testing

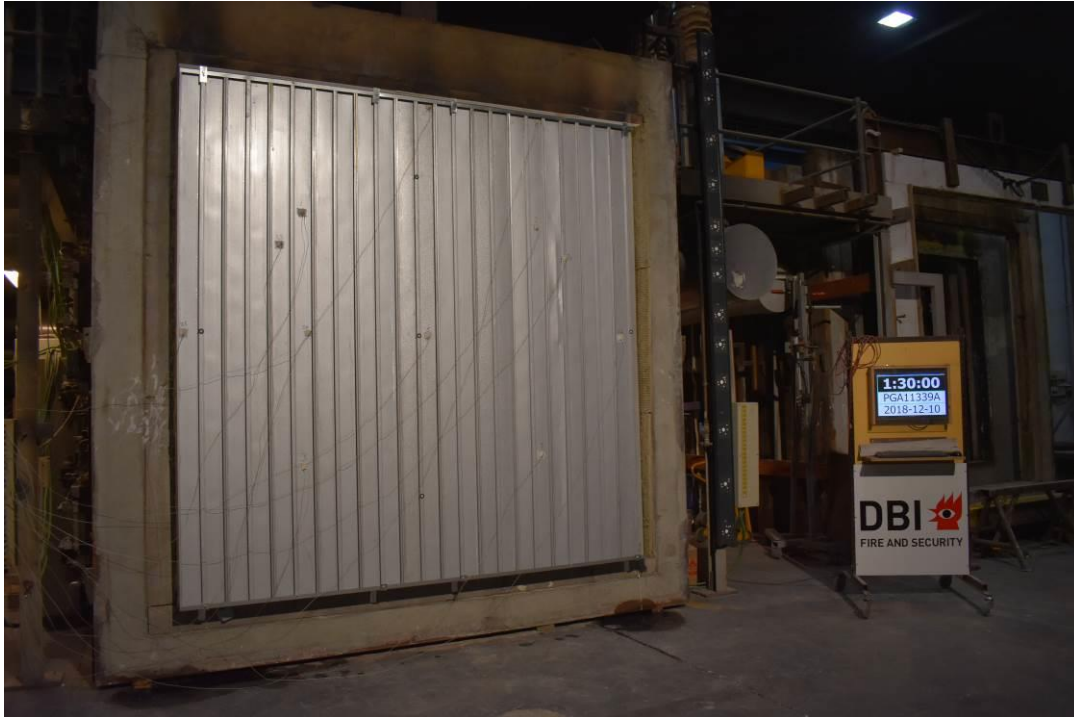
Photo No. 17 The test specimen seen from unexposed side after 90 minutes of testing

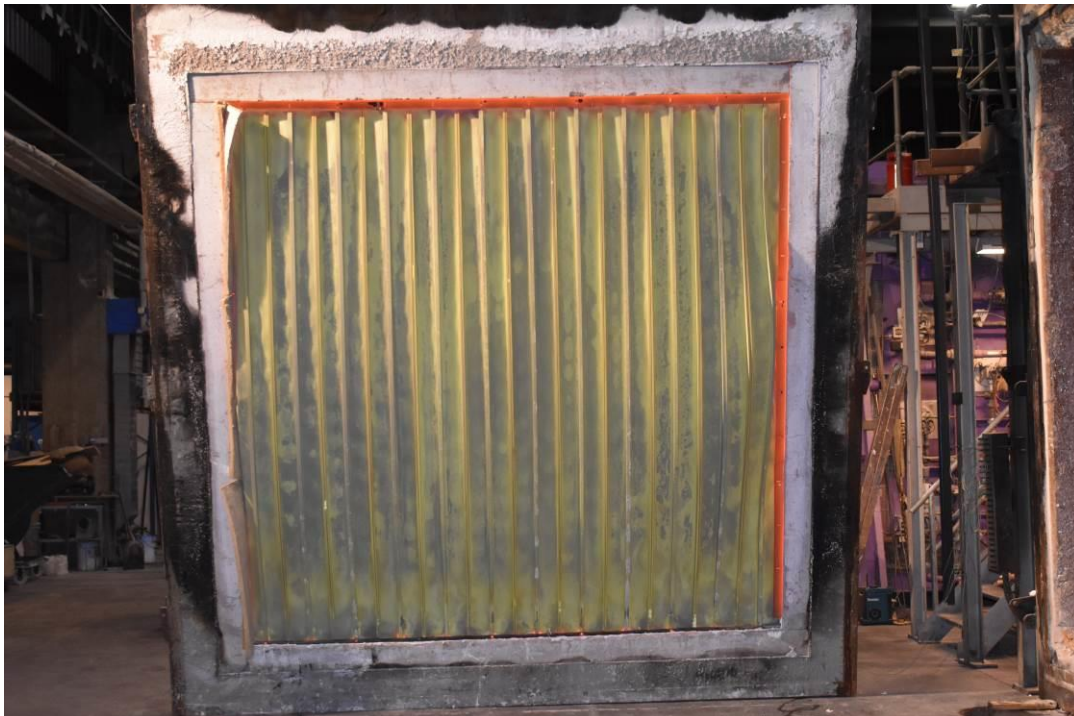
Photo No. 18 The test specimen seen from exposed side after testing

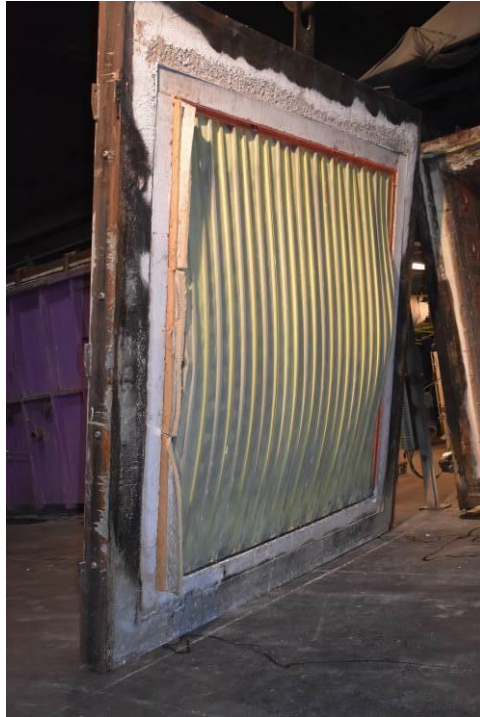
Photo No. 19 The test specimen seen from exposed side after testing

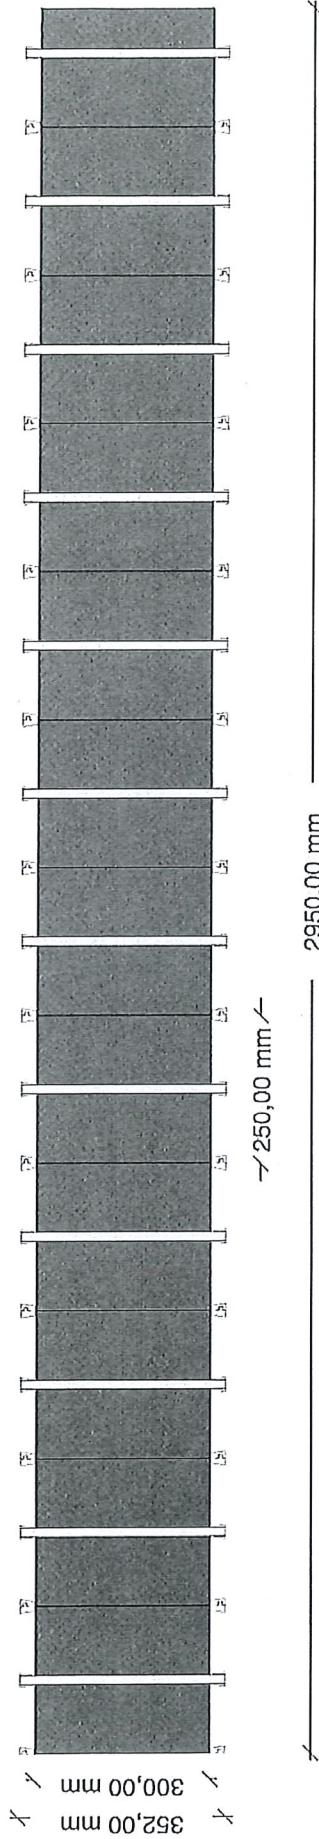
NORDIC BUILD INORGANIC BUILDING SYSTEMS	SNIT: Vænet snit
	Status: Teknisk afklaring
	SAG: NR.
SAG: Branchtest	TEGN. NR.
EMNE: Ikke-bærende facadeelement	1
DATE: 26.11.2018	MÅL: Scale t/m.
REV A:	B: C: D:
	UDF af: INK
	GODK:

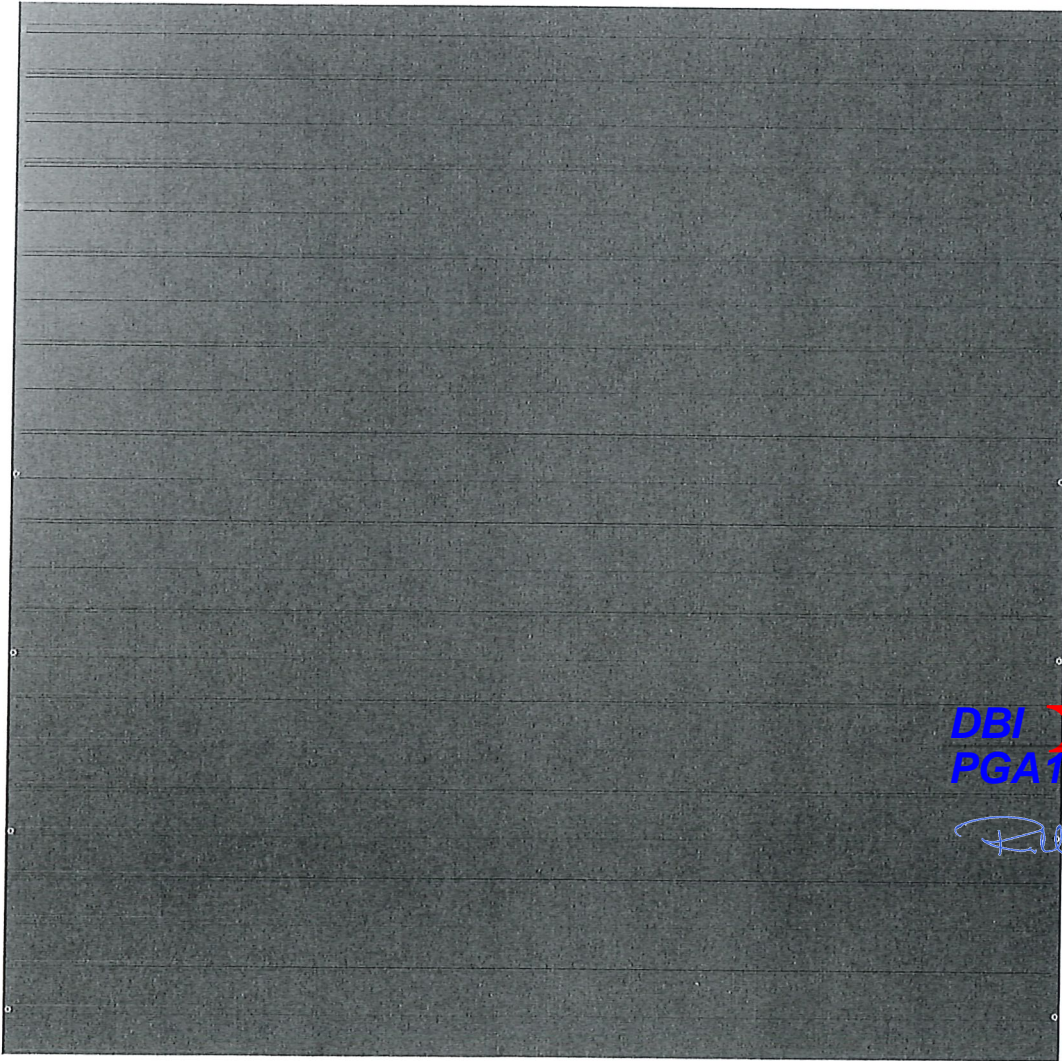
...ring af blindnitter til fastgørelse.

NORDIC BUILD INORGANIC BUILDING SYSTEMS		SNIT: Opsalt front
SAG: Brandtest		Status: Teknisk afklaring
EMNE: Ikke-bærende facadeelement		SAG: NR.
DATO: 26.11.2018		TEGN. NR.
REV A:		2
MÅL: Scale 1/1m	UDF af: INK	GODK:
B:	C:	D:

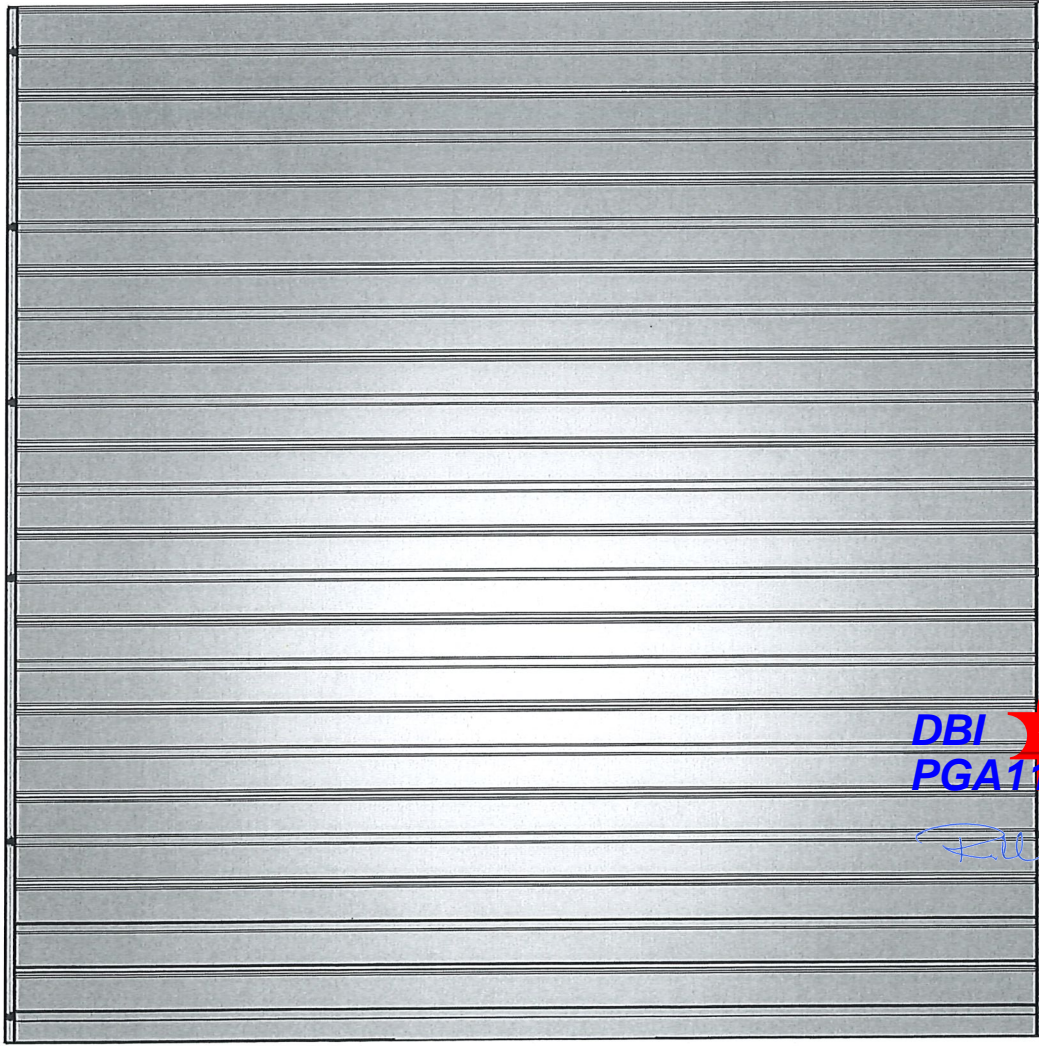
Placering af blindhitter til fastgørelse.

VINKELSKINNE

NORDIC BUILD INORGANIC BUILDING SYSTEMS		SNIT: Opstalt, bagside
SAG: Brandtest		Status: Teknisk afklaring
EMNE: Ikke-bærende facadeelement		SAG: NR.
DATE: 26.11.2018	MÅL: Scale tfm.	TEGN. NR. 3
REV A:	B:	GODK:
	C:	D:

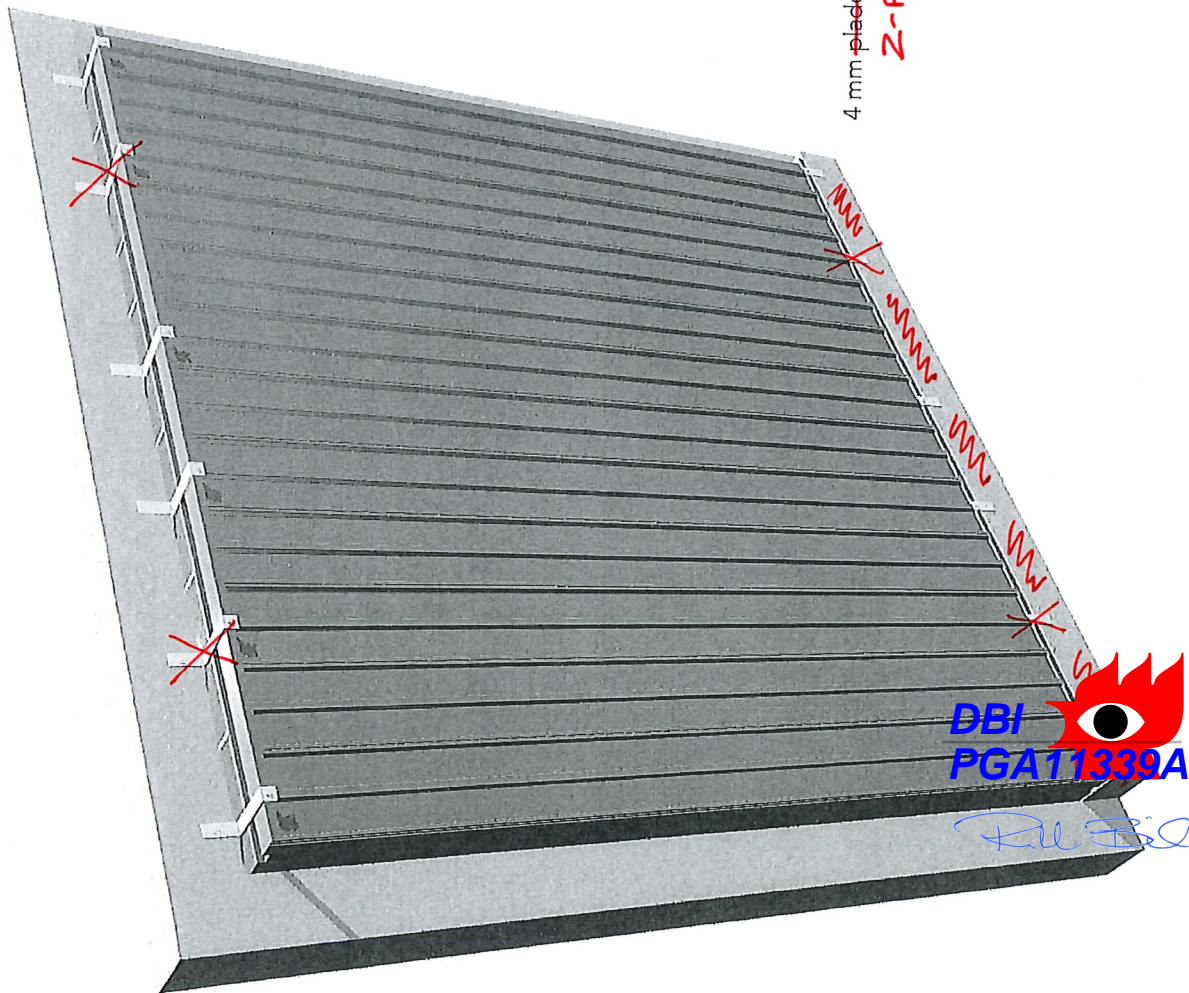
Z-profiler i 4 mm pladestål, fastholder elementet til betonforkant.

4 mm pladebeleg, fastholder emnet til betonforkant.

Z-PROFILER

NORDIC BUILD INORGANIC BUILDING SYSTEMS		SNIT: Perspektiv
SAG: Brandtest		Status: Teknisk afklaring
EMNE: Ikke-bærende facadeelement		SAG: NR.
DATE: 26.11.2018		TEGN. NR. 4
REVA: B:	UDF af: INK	GODK:
C:		D:

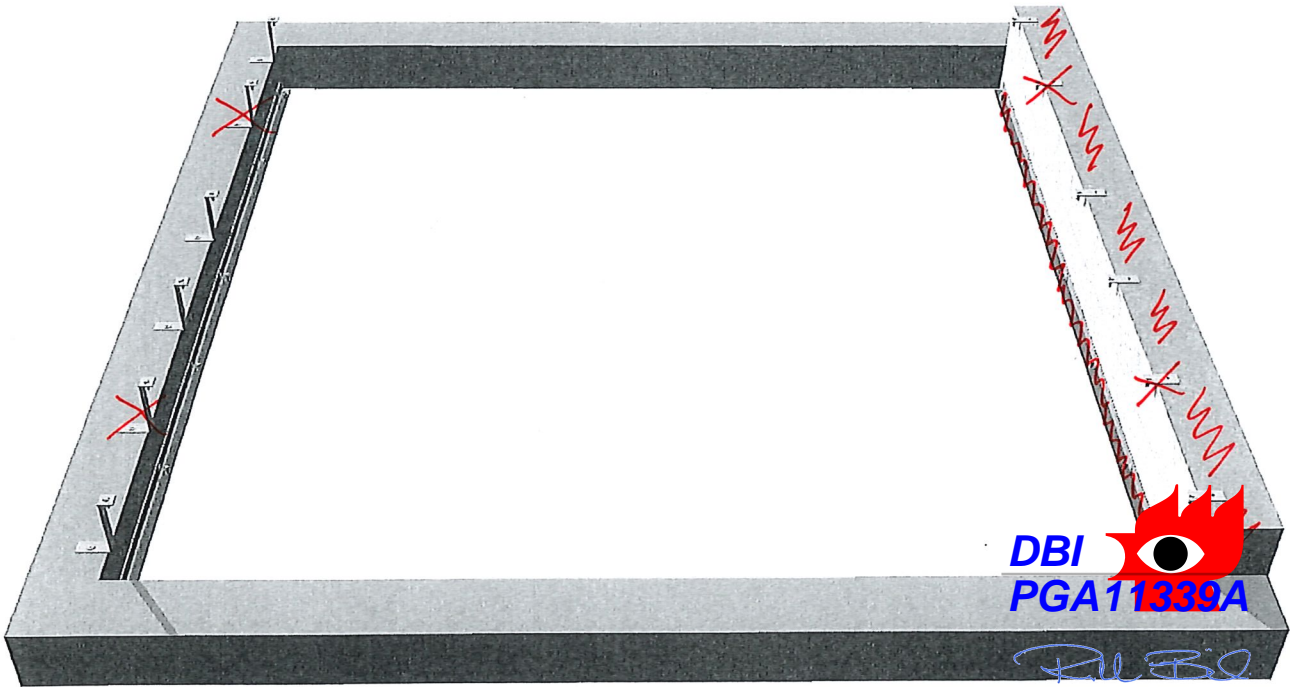
PLACERET 20 MM FRA
 ✓ BAGKANT TEST RAMME

Vinkelskinne-beslagene i top og bund, på betonrammens
 inderside, fastgøres før emnet løftes på plads.

De udvendige beslag fastgøres når emnet er på plads.

NORDIC BUILD <small>INDOOR/OUTDOOR BUILDING SYSTEMS</small>		SNIT: Perspektiv	
		Status: Teknisk afklaring	
		SAG: NR.	
SAG: Brandtest	TEGN. NR.	5	
EMNE: Ikke-bærende vægselement	UDF af: INK	GODK:	
DATE: 26.11.2018	MÅL: Scale tfm.	B:	C:
REV A:			D:

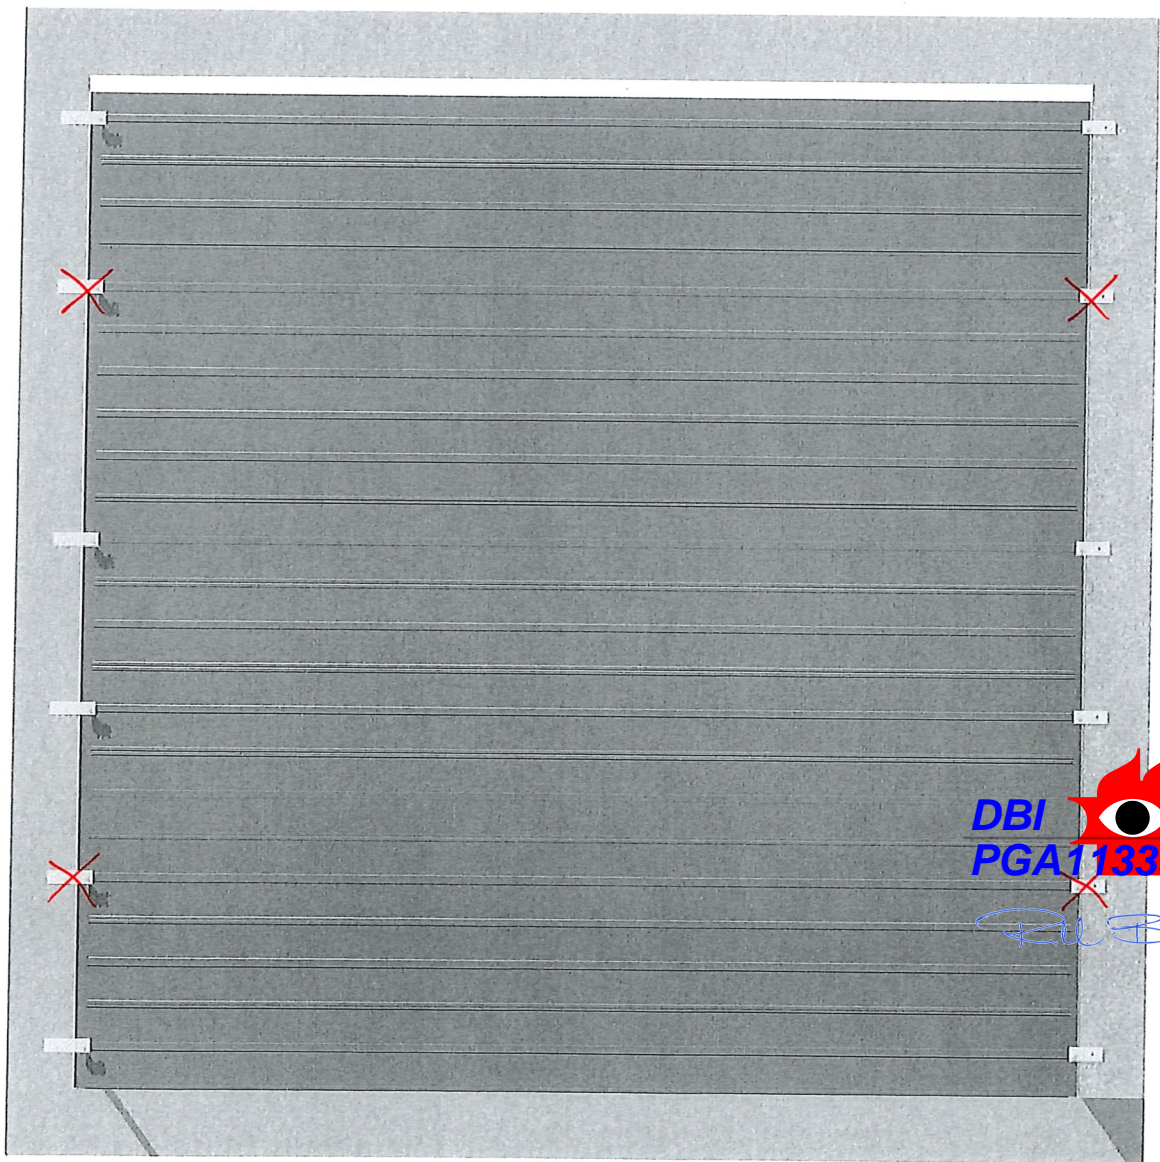
De udvendige Z-profiler **og pladebeslag** fastgøres med 8 mm maskinskruer til blindhitterne i vægelementets over og underkant.

SNIT/Opstalt: Front
		Status: Teknisk afklaring
SAG: Brandtest		SAG: NR.
EMNE: Ikke-bærende facadeelement		TEGN. NR.
DATO: 26.11.2018		6
MÅL: Scale 1:1	UDF af: INK	GODK:
REV A:	B:	C:
		D:

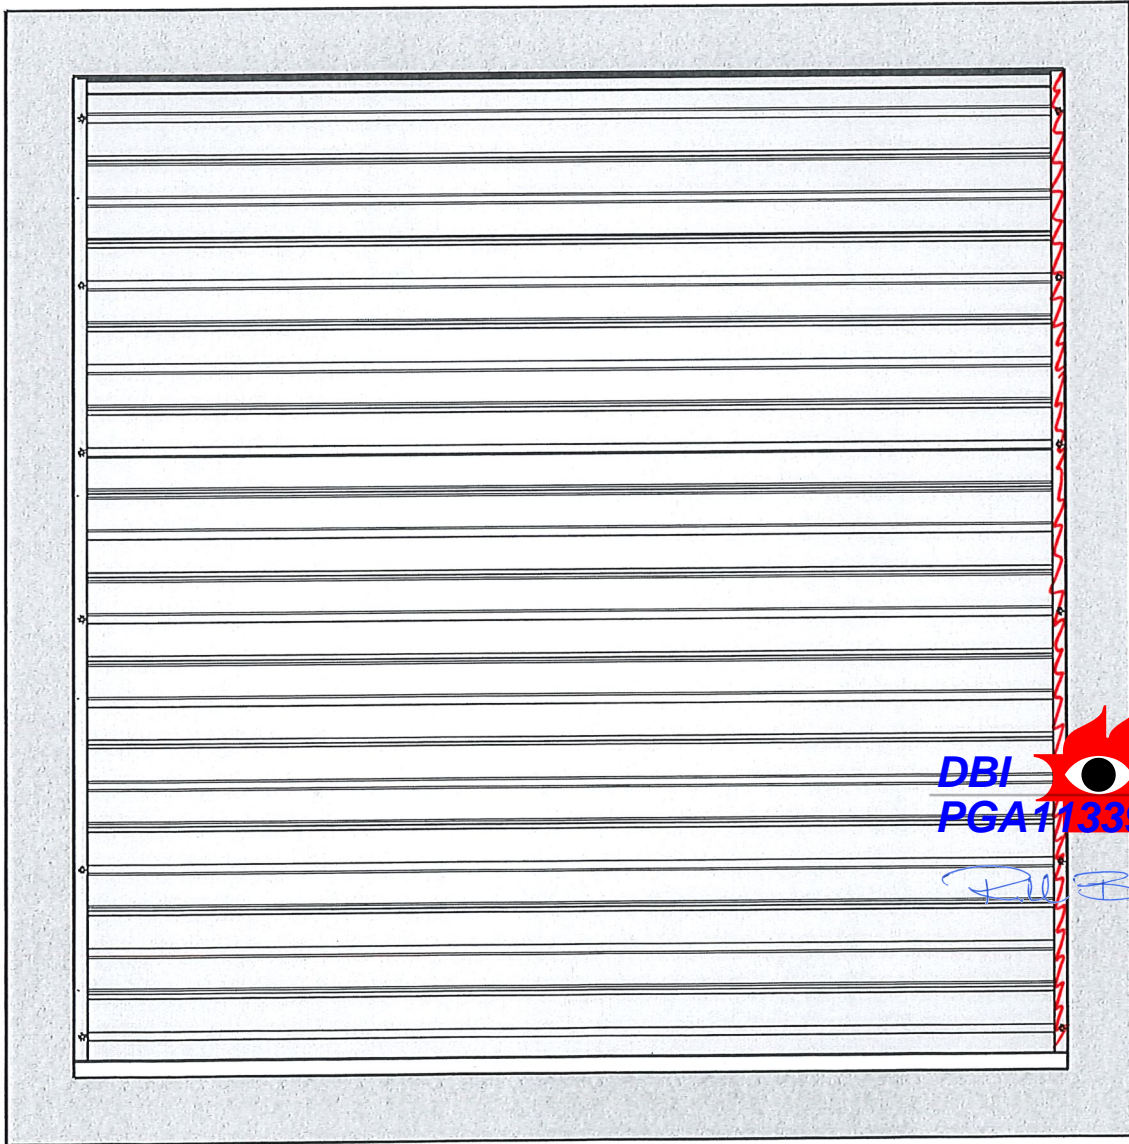
50x50

Vinkelskinne 4 mm: ~~40x40~~ mm, på betonrammens
inderside, fastgøres med 8 mm maskinskruer til blind-
nitte i væglements over-~~og~~underkant.

NORDIC BUILD INORGANIC BUILDING SYSTEMS		SNIT: Opstalt
SAG: Brændtest		Status: Teknisk afklaring
EMNE: Ikke-bærende facadeelement		SAG: NR.
DATO: 26.11.2018		TEGN. NR.
REV A:		7
MÅL: Scale 1:1	UDF af: INK	GODK:
B:	C:	D:

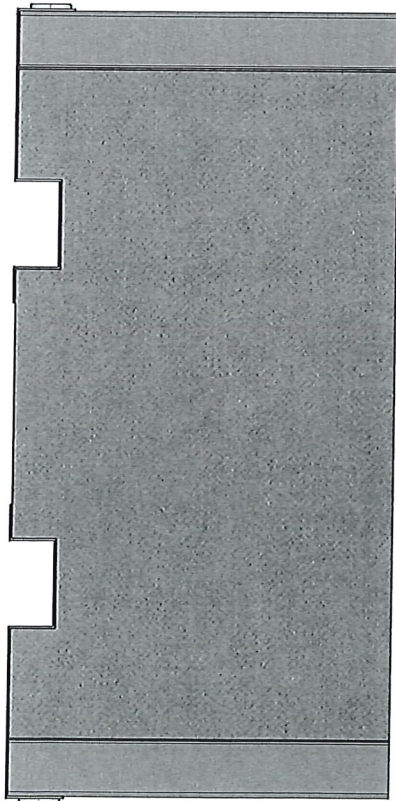
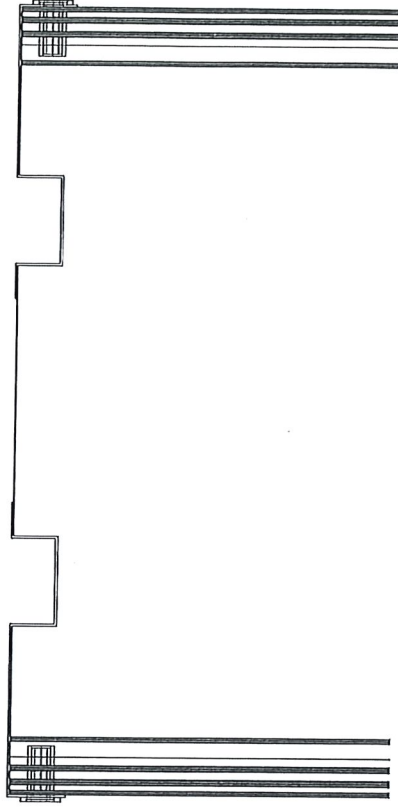
Blindhitterne spænder vægelementets kantprofiler sammen med panelerne, og skaber en ramme med stor stivhed. Kantprofilerne er 1 mm galvaniseret pladestål.

Blindhitterne har invendigt 8 mm gevind - og bund der sikrer lufttæthed.

NORDIC BUILD INDIGNITE BUILDING SYSTEMS		SNIT: Detalje
SAG: Brandtest		Status: Teknisk afklaring
EMNE: Ikke-bærende facadeelement		SAG: NR.
DATO: 26.11.2018		TEGN. NR.
REV/A:		8
MÅL: Scale tfm.	UDF af: INK	GODK:
B:	C:	D:

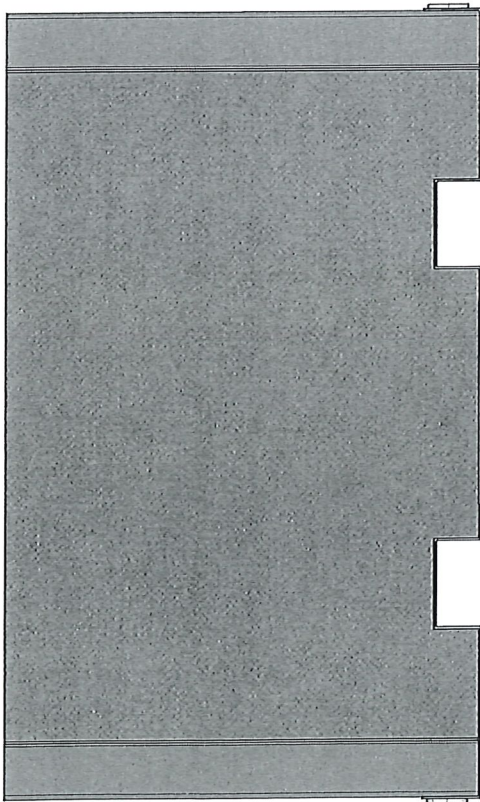
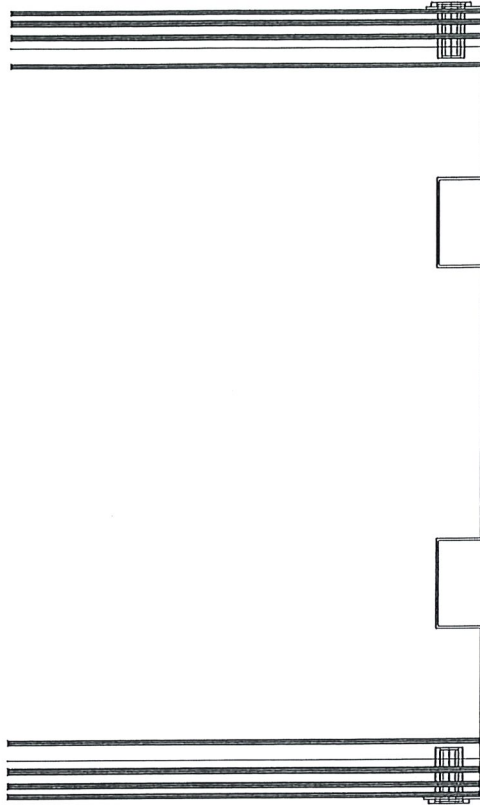
Blindnitterne spænder vægelementets kantprofiler sammen med panelerne, og skaber en ramme med stor stivhed. Kantprofilerne er 1 mm galvaniseret pladestål.

Blindnitterne har indvendigt 8 mm gevind - og bund der sikrer lufttæthed.

NORDIC BUILD INORGANIC BUILDING SYSTEMS		SNIT/Detailje
SAG: Brandtest		Status: Teknisk afklaring
EMNE: Ikke-bærende facadeelement		SAG: NR.
DATO: 26.11.2018		TEGN. NR. 9
REV A:	MÅL: Scale tfm.	GODK:
B:	UDF af: INK	D:
C:

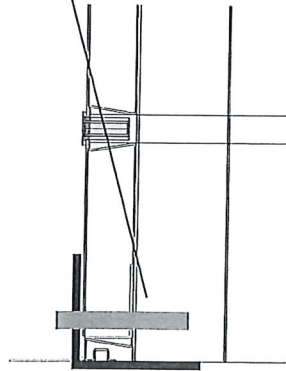
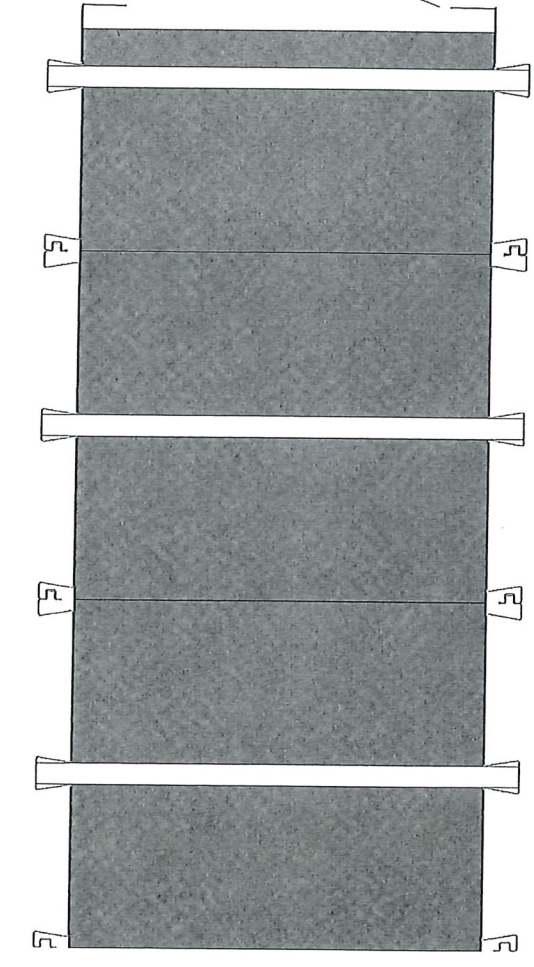
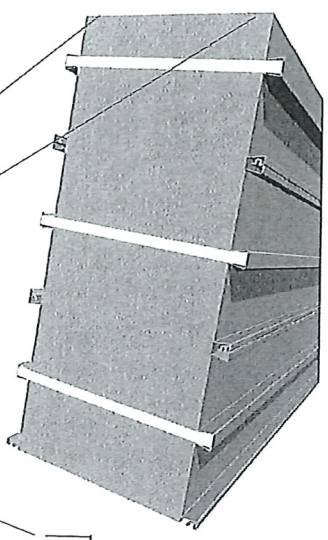
Vægelementets eksponerede side fastgøres i det lodrette snit til en vinkelprofil på samme måde som top og bund.
 Der etableres blindhitter til 8 mm maskinskruer i den lodrette fixed edge.

Vægpanelets 0,9 mm tyndplade ombukkes mod Free Edge.

Vægelementet er opbygget af standardpaneler på 250 mm. Et panel består af to 0,9 mm profilvalsede stålflanger forbundet af en 15 mm M4 Composite-kropsplade. Hvert panel udgør en I-bjælke.

Panelerne klemmes sammen i en lufttæt fer og not-lås.

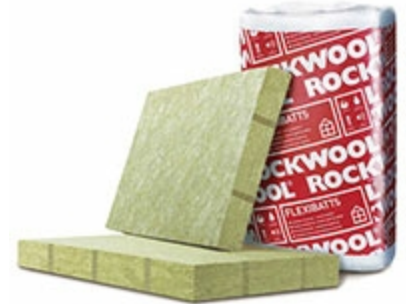
ROCKWOOL FLEXIBATTS 34 er formstabile isoleringsplader fremstillet af ubrændbar, fugt- og vandafvisende ROCKWOOL stenuld. ROCKWOOL FLEXIBATTS 34 er fleksibel i både længde- og bredderetningen. Flexzoner er afmærket på produktets kantflader. ROCKWOOL A/S anbefalede isoleringstykkelser fremgår af [Den lille lune](#).

FLEXIBATTS 34 anvendes til isolering af skråvægskonstruktioner og lette ydervægge. FLEXIBATTS 34 isolerer 8% bedre end FLEXIBATTS 37.
